In Mexico City, September 19<sup>th</sup> is a remembrance date of what the combination of large magnitude earthquakes with extreme soft sediments and bad constructions can cause. On the 19<sup>th</sup> September 1985, an interplate event (Mw 8,0; depth = 20 km; epicentral distance near 350 km) caused more than 10,000 casualties and about 190 buildings suffered partial or total collapse. Exactly 30 years later the 19<sup>th</sup> September 2017, and short after a macroearthquake drill, a Mw 7,1 intraslab earthquake hit Mexico City at 13:40 hours (local time). The seismological records of the 2017 event (depth = 57 km; epicentral distance near 114 km from the city) showed that the ground motion in frequencies between 0.4 and 1 Hz was anomalously large, and it was reported as the second most destructive earthquake in Mexico City, just after the 1985 event, with 369 casualties.

In this work we show the damage distribution in the south part of Mexico City, due to the 19.09.2017 event, where most of the extreme damage happened. This distribution had not been seen after interplate earthquakes, which can be explained by the closeness, the back azimuth the frequency content and the magnit

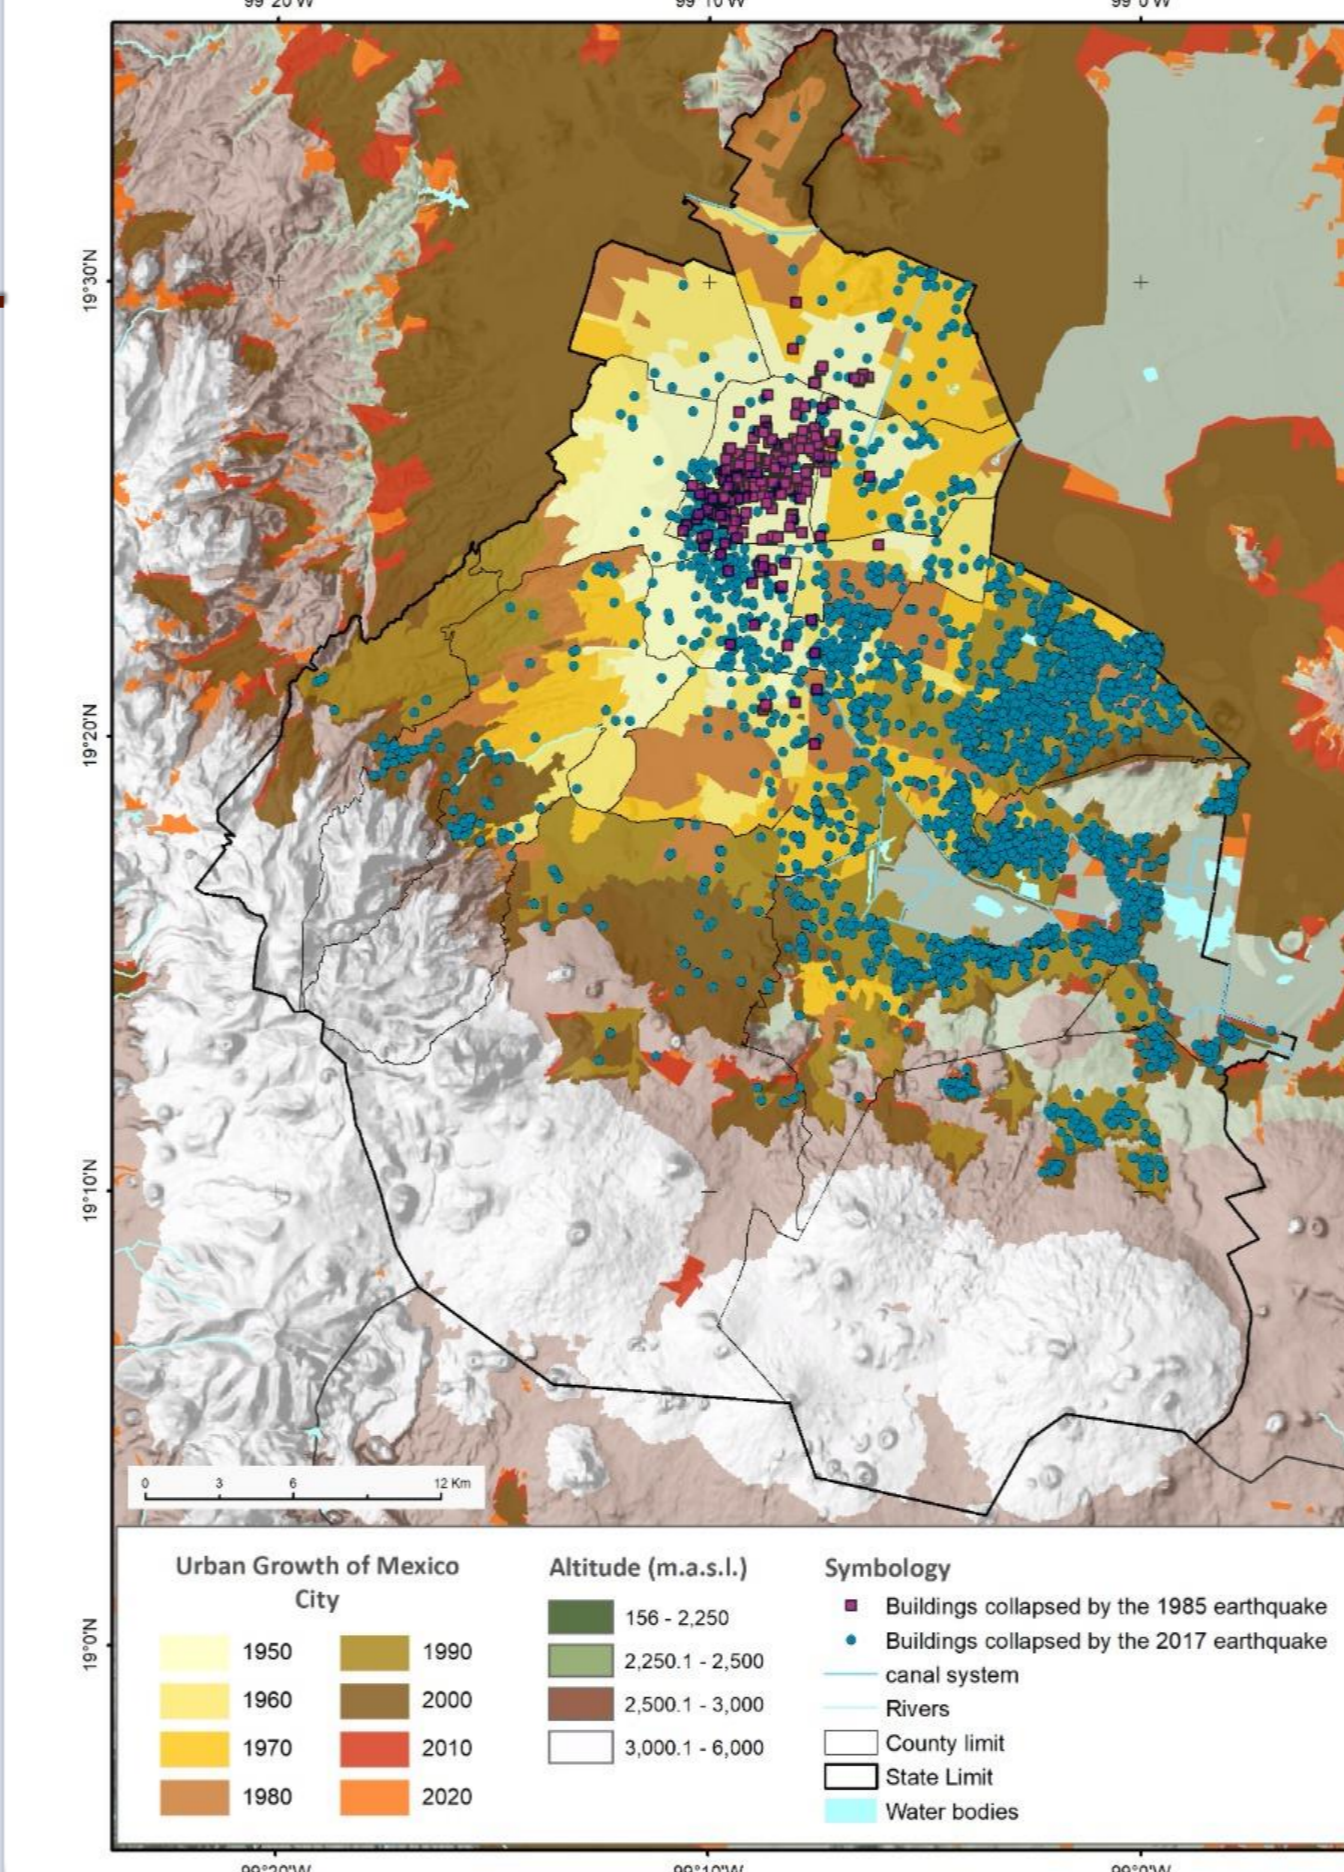
In Fig. 6 it is quite clear the damage distribution in the lake zone to the center of the city (yellow area) but increased dramatically to the southeast part of the basin. We identify many reason for this:

Fig. 6. Distribution of the collapsed buildings by the 19.09.1985 event in dark purple, and by the 19.09.2017 event in blue. The yellow to brown areas indicate the urban growth of Mexico City.

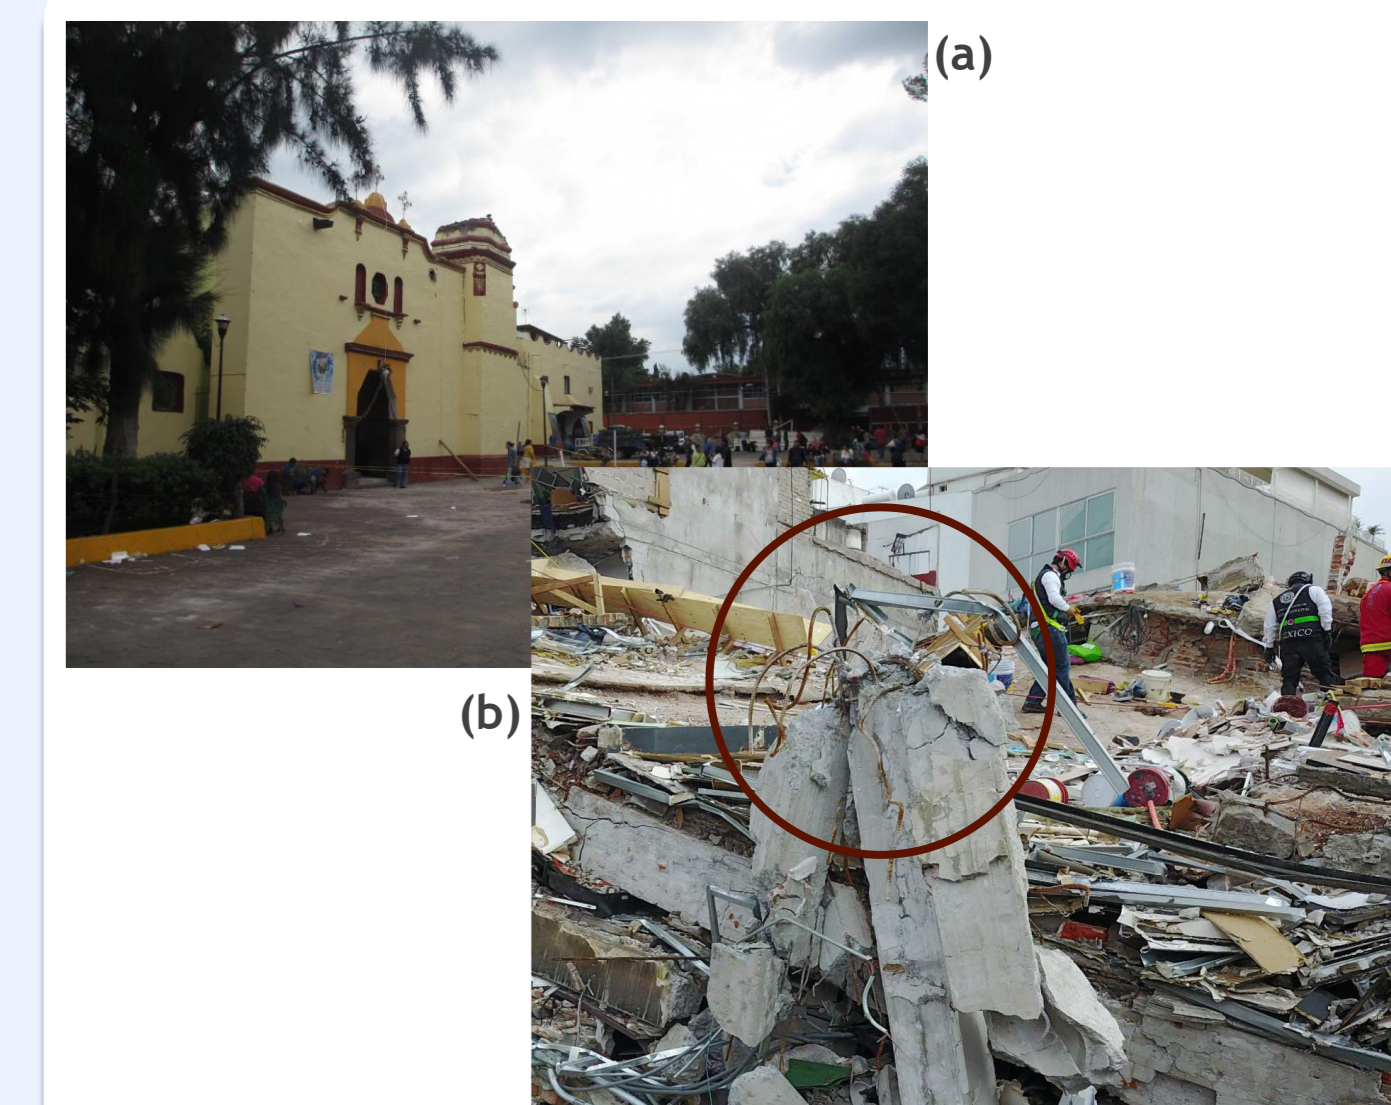
- The earthquake characteristics (magnitude, epicentral distance, frequency content)
- Age of many churches (see Fig. 7 a)
- Buildings didn't follow the seismic safety rules of the buildings code (see Fig. 7 b)

Fig. 7. Damages after the 19.09.2017. (a) Several old churches had severe damages. (b) Damages due to bad quality in buildings materials and construction.

However, intraslab events are not considered for the early warning system, they are rare, and they occur closer to the city, which changes the ground motion characteristics. This can explain part of the damages in old structures (i.e. churches) or structures which were built before 1985. However, most of the damage in recent urbanized areas (see Fig. 6), was due to a lack of the safety norms in the structures.

Most of the constructions built with the norms from the newest building code, did not collapse. This shows that the city seismic vulnerability can be reduced if the seismic safety norms are known and followed
