The marble sculptures of General Bülow and Scharnhorst in Berlin: comparative, non-destructive analysis of the weathering state after 12 years of exposure

Abstract

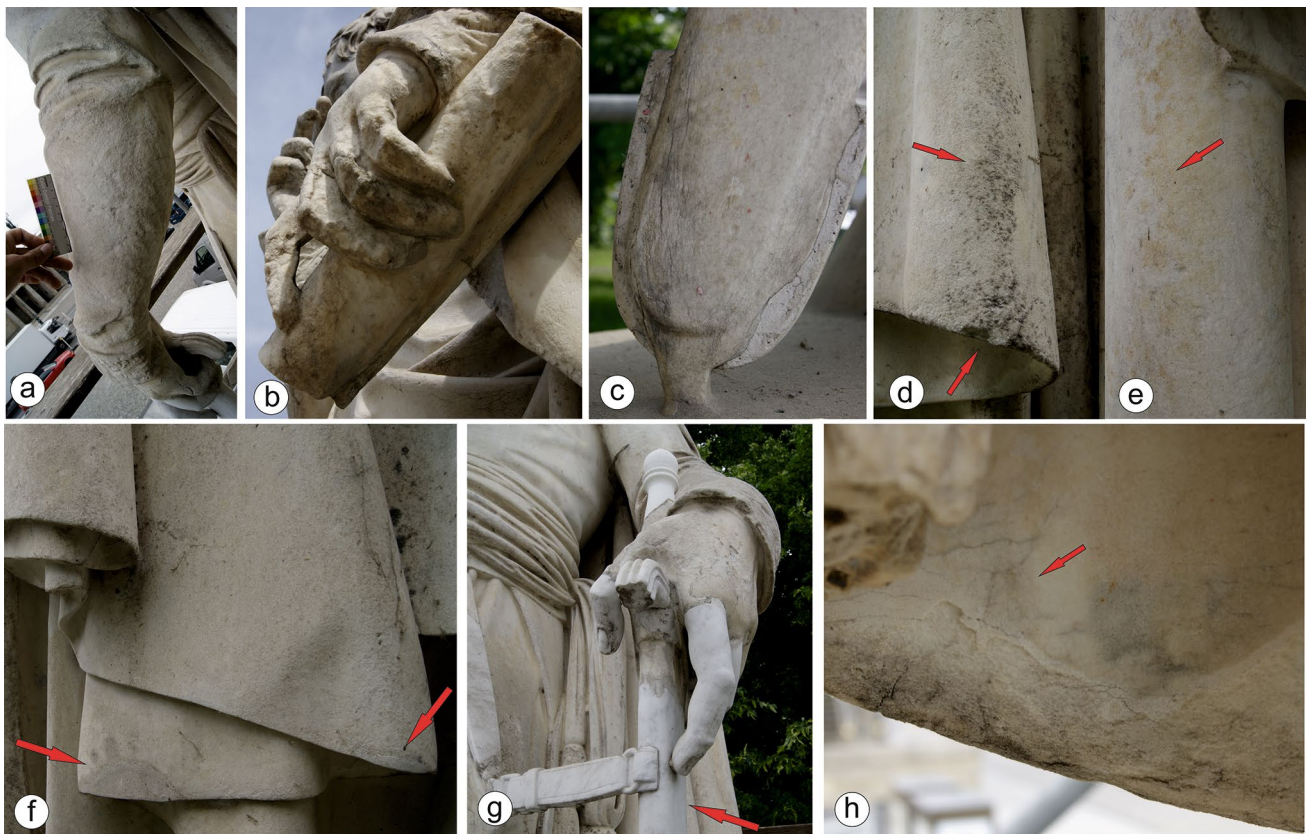
Both sculptures consist of a whitish marble variety known as the Carrara type from Italy. Several types of decay phenomena are visible on the sculptures as shown in Fig. 3. Areas which are directly exposed to weathering influences, like arms, hands and garment folds show characteristic sugaring of these surfaces (Fig. 3a). These are highly pronounced for the left hand and arm of the Scharnhorst sculpture (Fig. 3b), where the original surface is almost completely lost. This pronounced surface roughness can be traced back to chemical solution processes, while less exposed areas show almost no alteration of the surface. In some cases, cracks can be found, which are visible due to the increased accumulation of dirt in those areas (Fig. 3c). Especially the garment folds show many black dots (Fig. 3d), which probably are caused by microbial growth and can be found more prevalently in the narrow gaps between the folds. Another phenomenon is an ochre coating spread all over the sculptures, as shown in Fig. 3e. The cause of this coloration is still under discussion

Fig. 3 Various decay phenomenon found at the monument of General von Bülow and Scharnhorst with **a** sugaring of exposed surfaces, **b** strongly weathered surfaces with sugaring of exposed surfaces, **c**

cracks, **d** microbial growth, **e** discolouration, **f** lost material which was reconstructed by restoration mortar and **g** substitution made of marble and **h** Craquele on the surface

since it may be microbial growth or residues of former consolidation measures. Close examination needs to clarify this phenomenon. Several replacements of filigree parts can be found for example in the folds of the coat (Fig. 3f), where a restoration mortar was used to substitute the missing areas or (Fig. 3g) the total substitution by reconstructions made of marble. At the edge of Scharnhorst's coat, so-called Craquele can be observed on the surface, with a network of cracks; while the underlying fabric shows strong disaggregation (Fig. 3h).

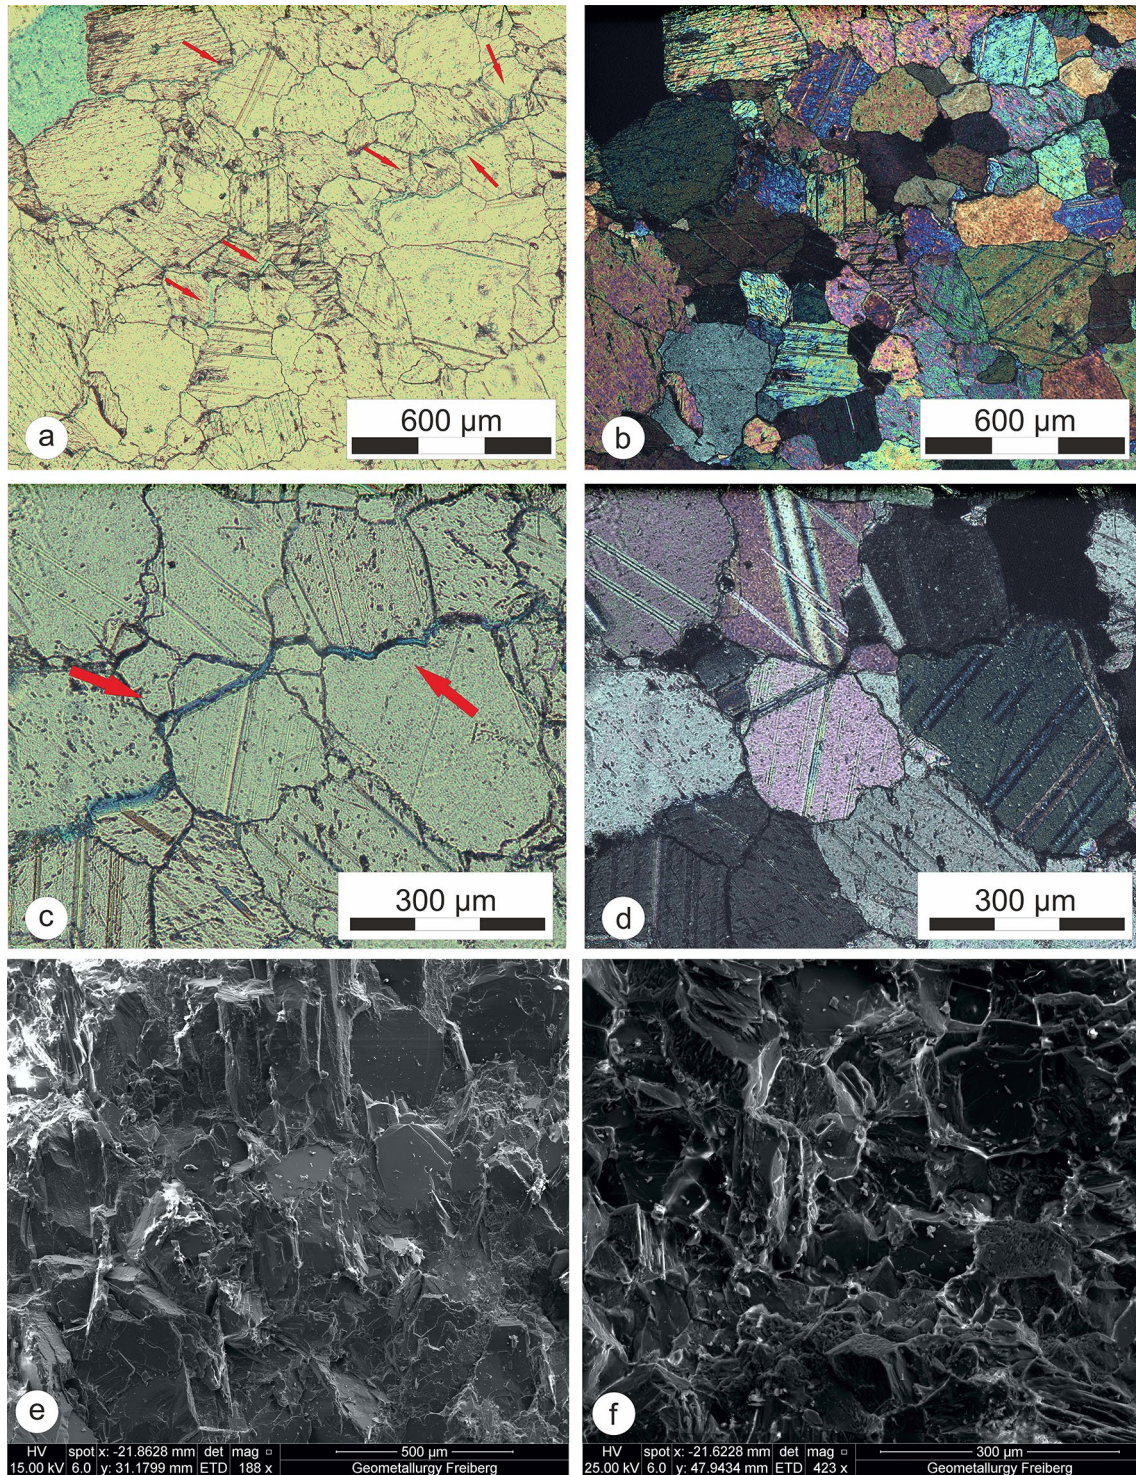
the sculpture, showing the fabric in a depth profile. Figure 4a and c shows that small cracks (marked with red arrows) run along the grain boundaries and can primarily be found between the grain to grain contacts, as so-called intergranular cracks. In Fig. 4c, an intragranular crack is observable, but this type of crack is less common. The crack distribution shows that they mainly occur in the first millimetres of the surface. They do not spread surface parallel, but slightly oblique into the depth of the drill core. Cracks at the outer areas of the drill core, parallel to the core should be disregarded, because they are caused by drilling and not related to weathering. Granular disintegration is observable in this core, but it is only weakly pronounced. Another important method for visualising these open grain boundaries is the use of scanning electron microscopy (SEM). SEM images were taken at a depth of about 4 cm (Fig. 4e) and at 6 cm (Fig. 4f) to the former surface. The grain contacts show no signs of granular disintegration at those depths.

Fig. 4 Thin section images with coloured resin to visualise open cracks. The left rim of all pictures is parallel to the former surface of the sculpture. **a** polarised image showing the area close to the former surface, with slightly oblique cracks (red arrows) **b** cross-polarised image of the same region with the same magnification as **(a)**; **c** detail

of a crack system, showing intergranular cracks as the most common crack type, beside an intragranular crack, **d** image **(c)** under crossed polarizers, **e** scanning electron microscopy performed for a piece of the marble core taken from a depth of 4 cm and **f** 6 cm

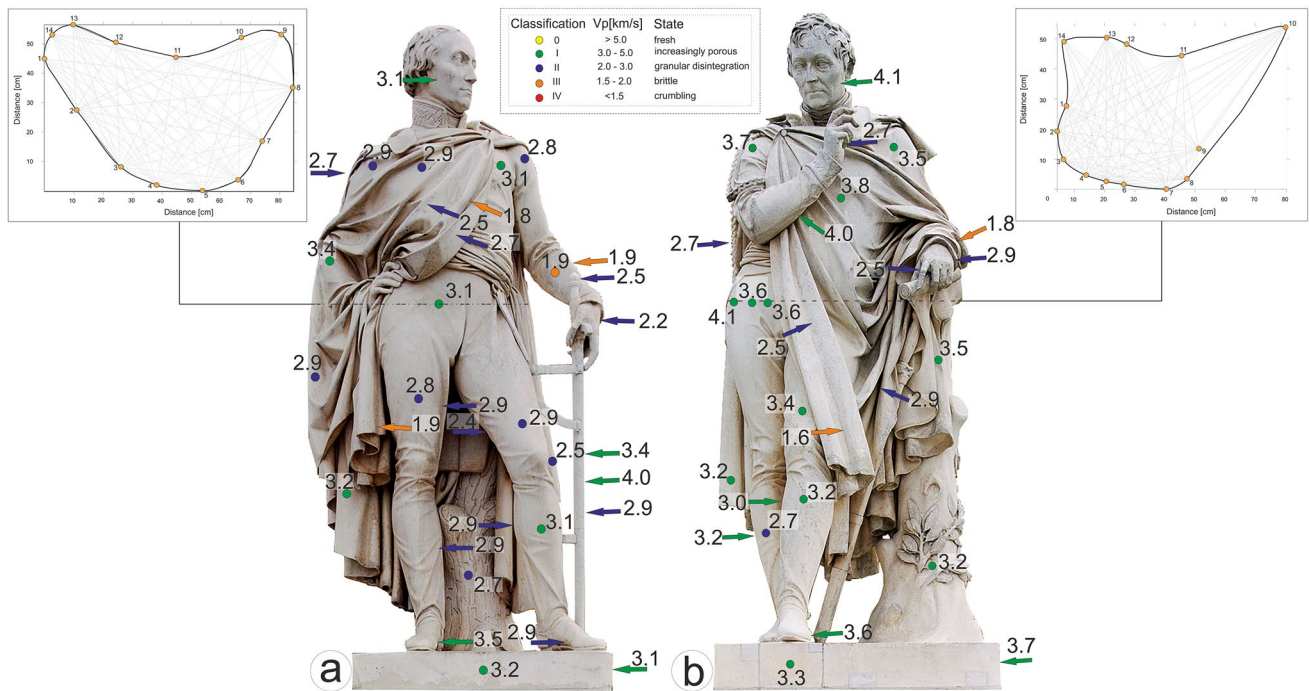
Figure 6a shows the analysed velocities [km/s] measured for General von Bülow during transmission. Each value is colour coded for a specific state of weathering. The analysed compressional wave velocities range between 1.8 and 4.0 km/s, while the highest measured velocity (4 km/s) was detected at the replaced sword. The highest velocity for the original material is 3.5 km/s for his right foot. With 2.8 km/s, the average velocity is very low and is classified as granular disintegration. The overall measured velocities show a distribution that indicates a dependence on how exposed elements are and their geometry. The lowest and most alarming velocities classified as brittle are found at the filigree parts of the sculpture and at the completely exposed areas of the arm. Moreover, even thicker parts of the sculpture such as the trunk exhibit ongoing signs of deterioration with a velocity of 3.1 km/s.

Velocities measured for General von Scharnhorst (Fig. 6b) indicate a slightly better weathering state for this sculpture, with a maximum velocity of 4.1 km/s at the hip

Fig. 6 Results of the ultrasonic transmission measurements performed in 2018 for General Bülow (a) and General von Scharnhorst (b). Arrows indicate the measurement direction from the left to right. Dots represent a transmission direction from the front to the back of

and head and the lowest measured velocity of 1.6 km/s at a garment fold. The mean velocity is, compared to General von Bülow, slightly higher with 3.2 km/s, reflecting the overall better conditions of this sculpture, 66.66% of the 27 measured velocities can be classified as increasingly porous. The geometry and exposition dependent velocity distribution as measured for Gen. von Bülow can also be observed for the Scharnhorst sculpture, while the thicker areas generally show higher values.

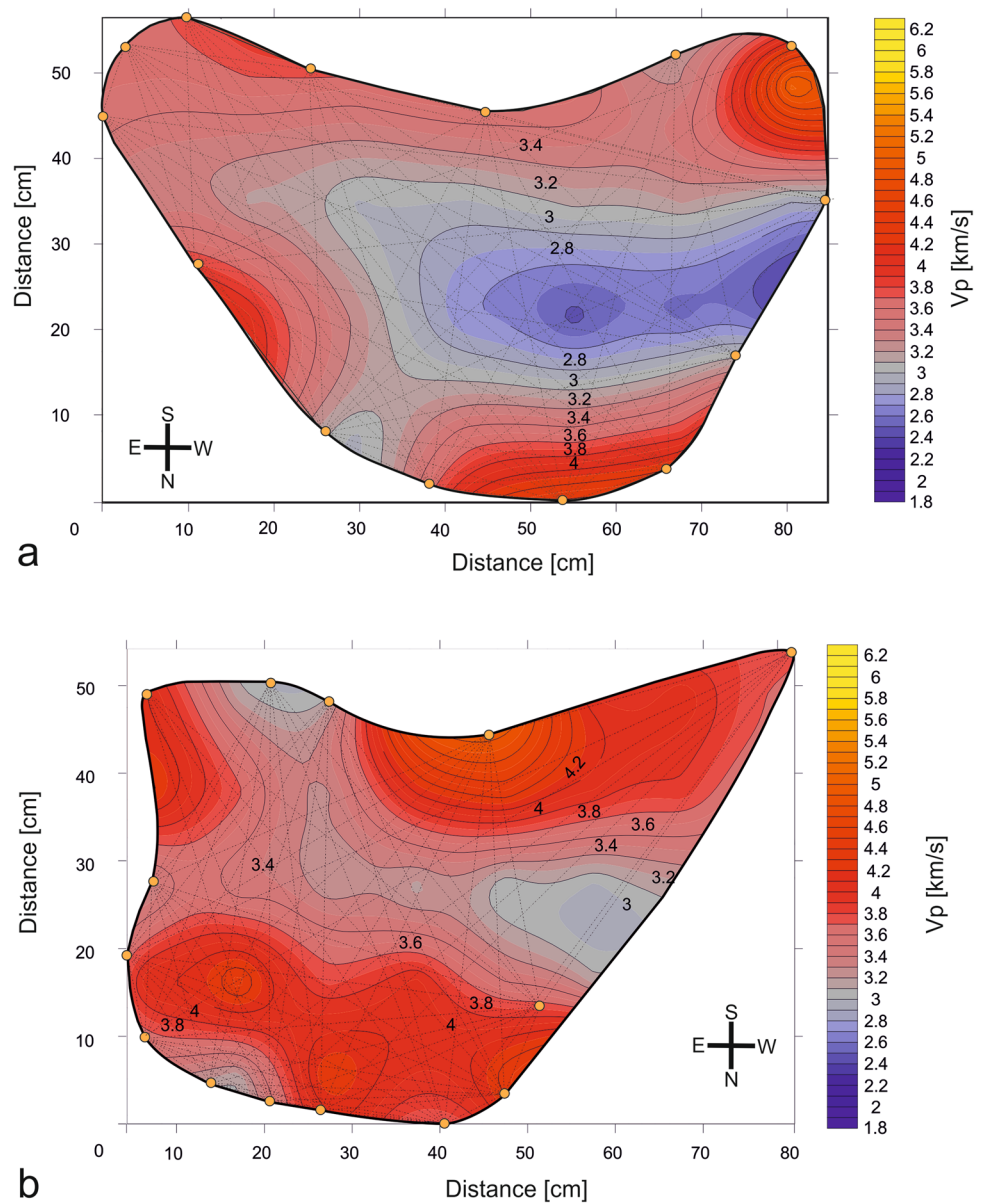
The tomogram calculated for General v. Bülow (Fig. 8a) shows a small channel of lower velocities (2.5–2.8 km/s) in the middle of the sculpture that are elongated to the west. The low velocities in the western part of the tomogram are

Fig. 8 Ultrasonic tomograms of General v. Bülow (a) and General v. Scharnhorst (b), computed for the horizontal sectional planes shown in Fig. 7. Velocities are given in km/s, the compass direction is given in the left (a) and right (b) corner of the plot. The lower edge of both tomograms represents the front view of both sculptures

in an area with low or no ray coverage. The highest velocities can be found in the northern direction, which is the front of the sculpture. The higher ultrasound velocities are arranged like a “U” dipping to the west, surrounding the low east–west striking velocity channel. The majority of the tomogram is characterised by velocities between 2.8 km/s and 3.6 km/s; the highest values can be found selective along the rim of the tomographic plane. This area needs a sensitive and careful interpretation because the number of rays, travelling this area is very low. The tomogram displayed for General v. Scharnhorst (Fig. 8b) shows fewer areas with lower velocities where values range between 3.0 and 5.0 km/s. The small zone in the western part of the tomogram is again an area with low ray coverage. The highest velocities can be found in the northern part of the tomogram; while the lower velocities run through

the tomogram as a belt in the middle of the tomographic plane, striking east–west, further as an area in the north-east and south-east of the tomogram. Most areas of the tomogram show velocities between 3.4 and 4.2 km/s, confirming the transmission measurements, that this sculpture is in a slightly better state of condition than v. Bülow.

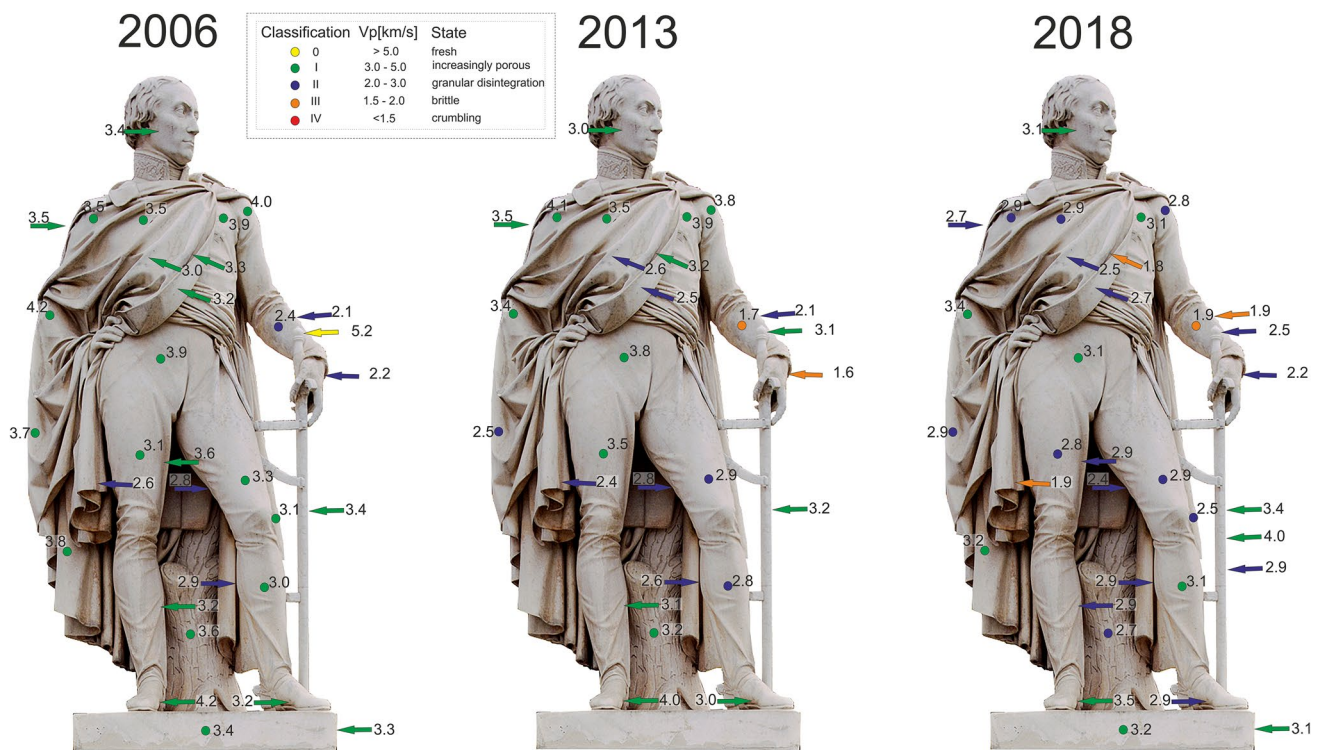
Figure 9 shows the measured velocities [km/s] received for General von Bülow in 2006, 2013 and 2018. The velocities for most parts of the sculpture slowed down during the investigated timespan and changed from the classification of increasingly porous (green) to granular disintegration (blue). The maximum velocity in 2006 was measured on a part of the substituted sword handle with 5.2 km/s. While the handle slowed down to 2.5 km/s, the highest measured velocity (4 km/s) was in 2018, detected on the substituted sword. As this was an additional measurement, no correlating value with the study in 2006 exists. The maximum velocity measured for the original material in 2006 was 4.2 km/s, in comparison with the maximum of 4.0 in 2013 and 3.5 km/s in the present study. The lowest velocity measured in 2006 was 2.1 km/s for the left arm, which showed no reduction in 2013 and slowed down to 1.9 km/s in 2018. The lowest velocity in 2013 measured on the left hand was 2.2 km/s, which is the same in 2018 as in 2006. In 2018 the lowest velocity detected was on a mantle fold with 1.8 km/s, which was much higher in 2006 (3.3 km/s) and 2013 (3.2 km/s). The mean velocity was 3.4 (± 0.62) km/s in 2006, 3.0 (± 0.67) km/s in 2013 and has decreased to 2.8 (± 0.46) km/s in 2018, which is a reduction of 15.7% during the last 12 years and 5.7% within the last 5 years.

Fig. 9 Measured ultrasonic velocities, analysed using the pulse transmission technique, given for the sculpture of General v. Bülow in 2006, 2013 and 2018. Arrows indicate a lateral (east–west) attachment of the probes, while the dots represent the north–south direction

The degree of deterioration for both sculptures shows an alarming state and therefore, restoration measures need to be undertaken. One possibility could be the application of consolidation materials, which is difficult, as there are several requirements that need to be fulfilled. The consolidation materials need to reach a high penetration depth, which is almost impossible based on conventional application methods as rinsing or the usage of a brush as the marble has a very low water uptake. Another aspect is the material itself. Acrylic resins and their application depths are connected to the used solvent and a possible and very common migration back to the surface as soon as the solvent evaporates. Also, the physical properties of the consolidation material can cause further problems. An alternative could be the application of vacuum induced treatments. In October 2018, the Neptune grotto in Potsdam, Park Sanssouci was reopened after a successful acrylic total impregnation (ATI) by Ibach GmbH (see Lachmann 2019). The use of a modified fluid for the so-called ATI 50 treatment should cause lower thermal expansion as the former formulation, as well as the thermal stress, which occurs during the treatment should be lower (see Sobott and Jbach 2019). Another possibility is the transfer of both sculptures to a museum storage to ensure stable environmental conditions, while the sculptures could be replaced with copies.

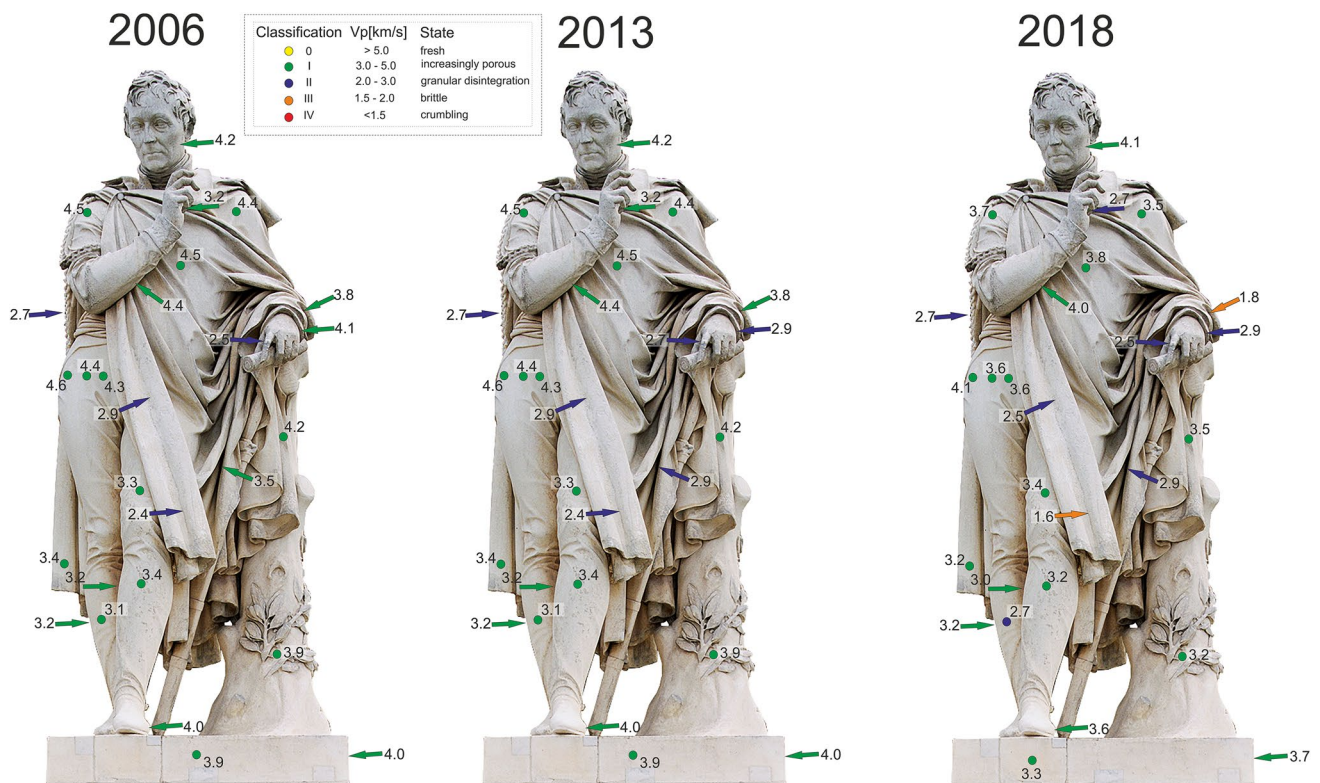
Figure 10 displays the velocity evolution for the sculpture General von Scharnhorst using the same classification and colour code as in Figs. 6 and 9. In 2006, the velocities indicate a slightly better weathering state for this sculpture with a maximum velocity of 4.6 km/s and a minimum velocity of 2.4 km/s; whereas the velocities received in 2018 at the same position are now reduced to 4.1 km/s (max) and 1.6 km/s. They remained almost stable until 2013. The mean velocity decreased from 3.7 (± 0.63) km/s in 2006 down to 3.4 (± 0.88) km/s in 2013 and 3.2 (± 0.62) km/s in 2018. The velocity reduction is about 14.7% within the last 12 years and 5.1% since 2013. The sculpture of Gen. v. Bülow shows a higher decrease of the ultrasonic values and that the deterioration is constantly increasing, independent

Fig. 10 Measured ultrasonic velocities, analysed using the pulse transmission technique, given for the sculpture of General v. Scharnhorst in 2006, 2013 and 2018. Arrows indicate a lateral (east–west) attachment of the probes, while the dots represent the north–south

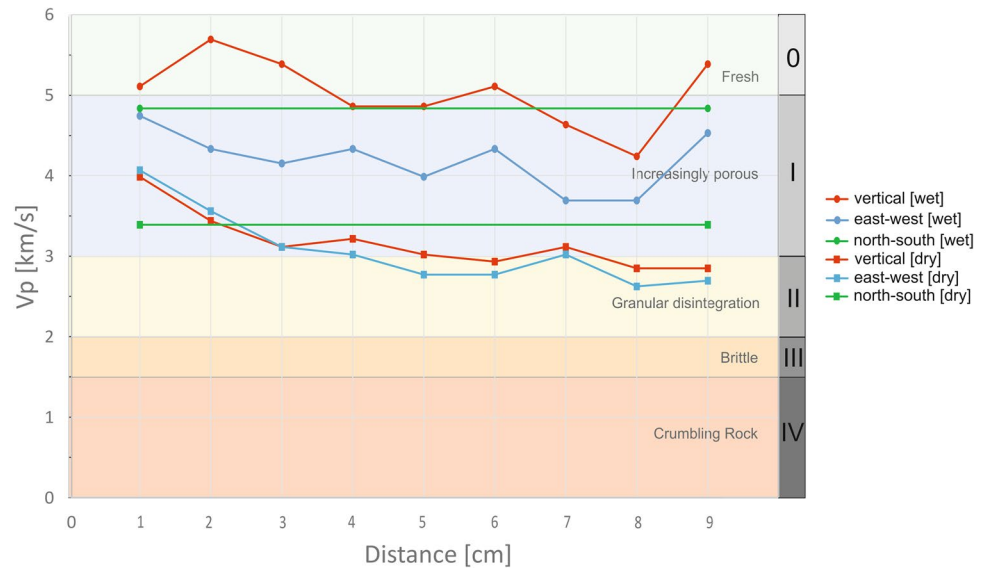
Fig. 11 Ultrasound velocities measured for a drill core from the von Bülow sculpture under dry (square markers) and wet conditions (dots). The green line represents the velocity investigated for the whole length of the core, according to the north–south compass direction. The red and blue values were received in the horizontal east–west direction (blue) and vertical direction (red). The measurements were executed as a depth profile, 1 cm is almost the former surface of the sculpture and 9-cm depth into the sculpture. Velocities were measured with a distance of 1 cm between the measuring points

Generally, the velocities measured for the core are low and can be classified as granular disintegration (see Fig. 11); while at the SEM pictures, taken at a depth of 4 cm (Fig. 4e) and at 6 cm (Fig. 4f), the marble shows no open grain

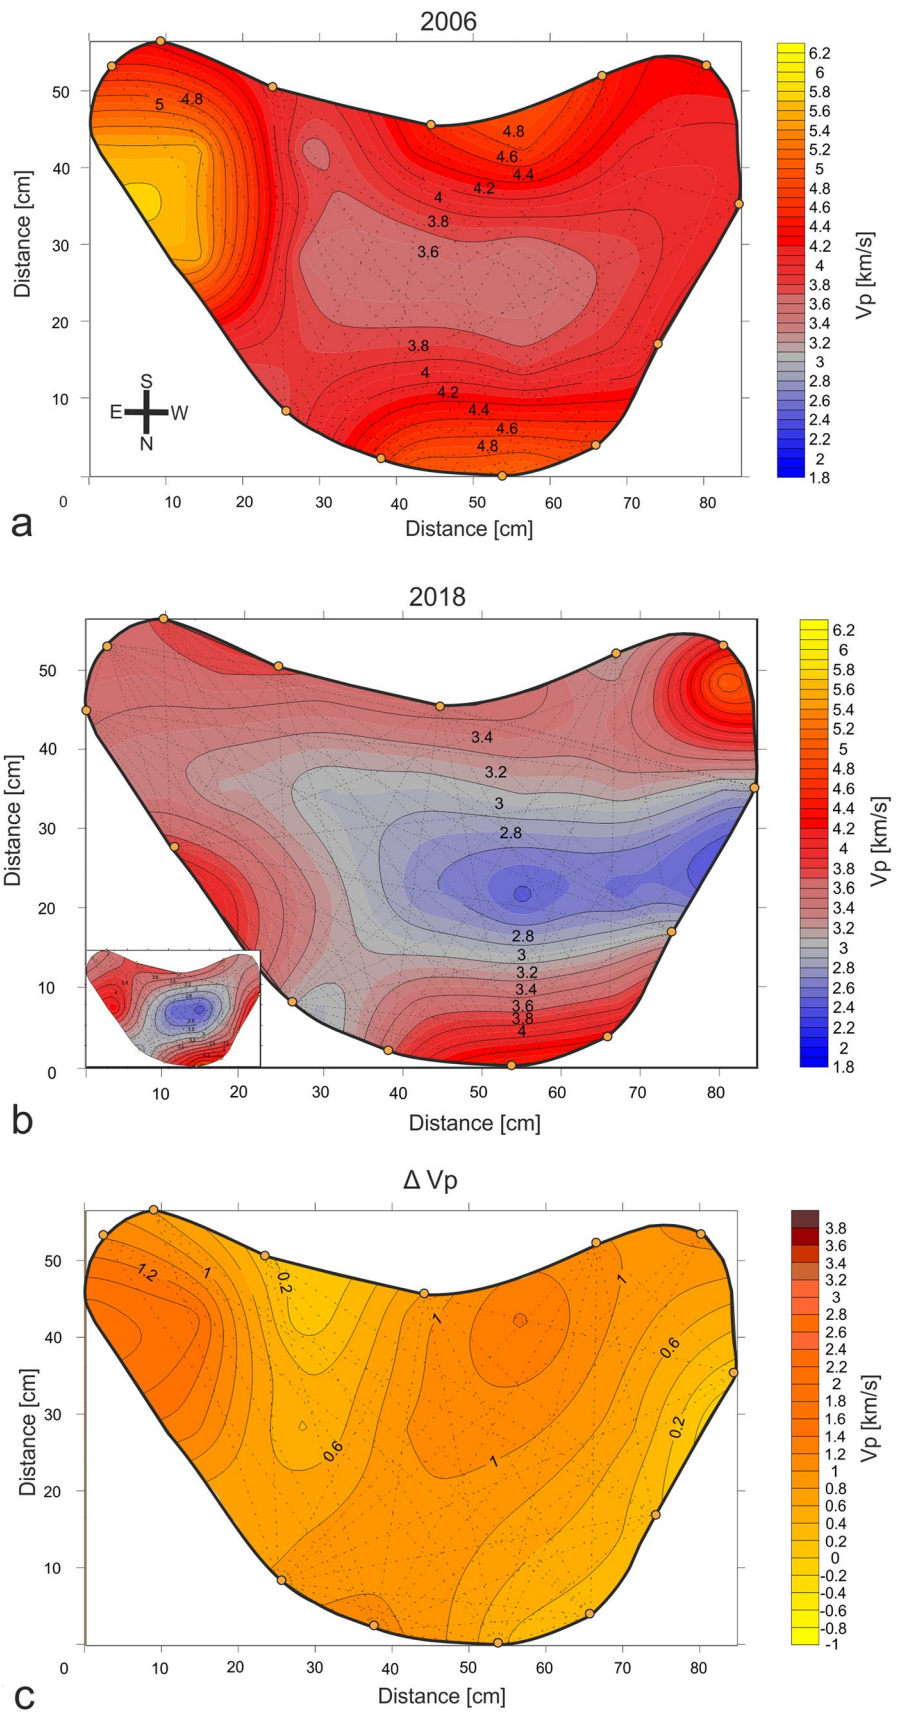
Fig. 13 Ultrasonic tomogram for General v. Bülow measured in **a** 2006, with lower ray coverage, **b** 2018 higher ray coverage and **c** ΔV_p modelled by the difference of **(a)** and **(b)**, while the amount of rays for the measurement in 2018 was adjusted to the lower amount of rays for the 2006 tomogram (small picture in **b**)

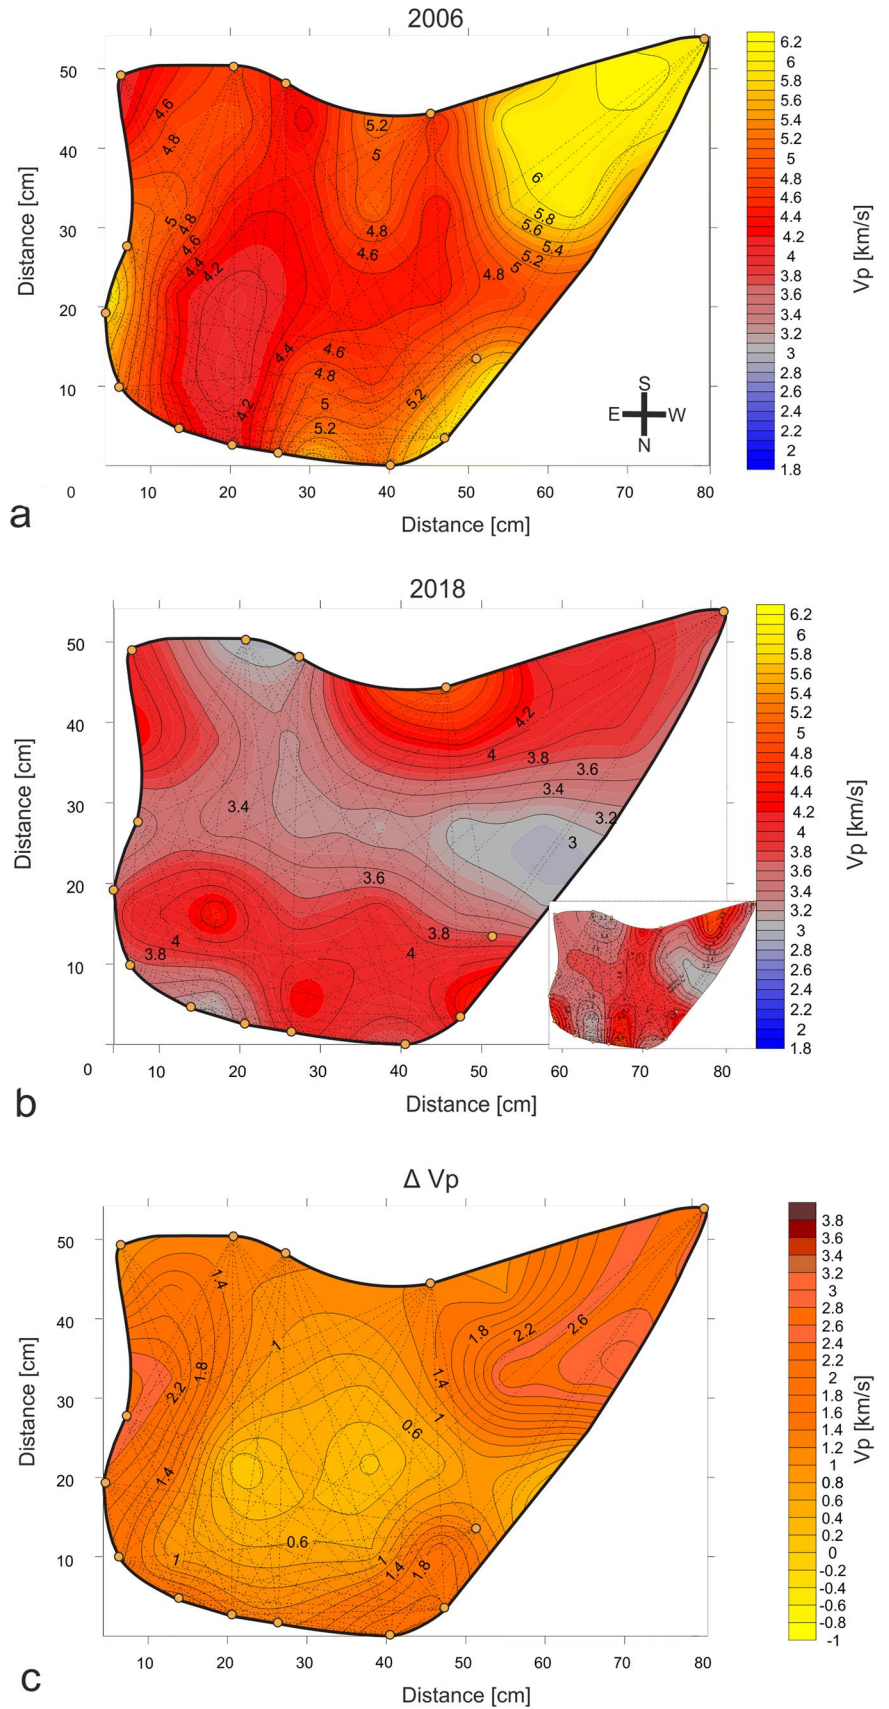
The tomograms for General v. Scharnhorst, depicted in Fig. 14 show a different distribution. Here, the velocities in 2006 (a) ranged between 4.2 and 6.2 km/s, while the zone in the south-west showing high velocities was only passed by a few crossing ray paths; therefore, this area should be interpreted with care. The velocities of 2018, shown in Fig. 14b, are lower than in 2006 (a), but unlike the tomograms of General v. Bülow, the reduction is primarily located at the outer areas of the sculpture. The ΔV_p tomogram in Fig. 14c shows that the eastern and western areas are stronger deteriorated than the middle, where the reduction was not that high.

Fig. 14 Ultrasonic tomogram for General v. Scharnhorst measured in **a** 2006, with lower ray coverage, **b** 2018 higher ray coverage and **c** ΔV_p modelled by the difference of **(a)** and **(b)**, while the amount of rays for the measurement in 2018 was adjusted to the lower amount of rays for the 2006 tomogram (small picture in **b**)

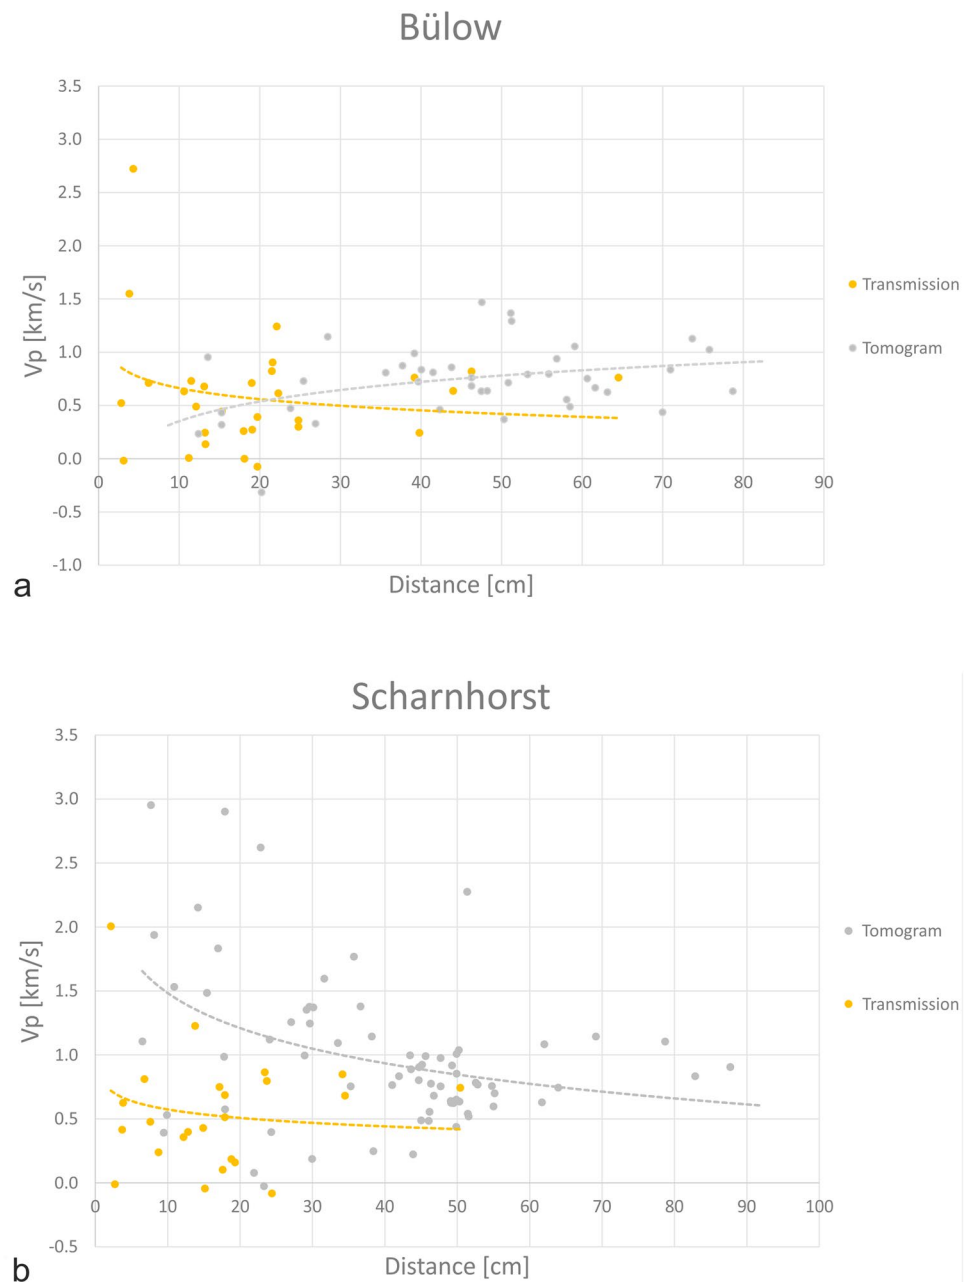
The direct comparison of the velocity reduction for each measured point since 2006, displayed in Fig. 16, shows that the transmission measurements (yellow dots) performed for Bülow (a) show a high reduction for short paths and a lower total reduction for longer distances. This

trend changes for the absolute reduction measured for the tomogram (grey dots). Here, the reduction increases with a greater thickness of the sculpture. This observation differs from the observations made for Scharnhorst (Fig. 16b), where the results for the tomographic plane show the same distribution, with higher reductions for short travel paths as measured for the different transmission measurements. Moreover, the values for the tomographic layer decreased more notably than for the single measurements. This unexpected result for Bülow may be explained by different reasons. First of all, the total number of measurements for a short distance have been smaller for Bülow in 2006 than for Scharnhorst; therefore, less velocities could be compared for these distances. Another aspect that could influence these results is a consolidation, which was performed in 2006 for the sculptures. Here, 3% Paraloid B72 was applied to optimise the conditions of that sculpture. The high volatility of the used solvent could lead to an enrichment of that consolidation material on the surface. This could also be an explanation for the higher velocities on the surface and the lower velocities in the middle of that sculpture, analysed by the tomogram. The lower velocity could also be strengthened by the influence of the texture, as described above. In contrast to this, the velocities analysed for General von Scharnhorst show a “normal” distribution with lower velocities for short distances and higher velocities for long distances. The velocities for the tomogram show a high reduction, with an average decrease of 1 km/s and a standard deviation of 0.6 km/s. The monument of Bülow shows an average reduction of 0.7 km/s and a standard deviation of 0.3 km/s. Due to the generally worse conditions for Bülow, the deterioration progress slows down as compared to Scharnhorst.

Fig. 16 Difference between the measured ray velocities in 2006 and 2018 (km/s) for von Bülow (a) and von Scharnhorst (b). The grey dots represent the reductions for the tomogram, while the orange dots represent the transmission measurements, plotted according to the distance (cm) the ray needed to travel
