> McLaren Vale Prescribed Wells Area groundwater monitoring status report 2002

# Report DWLBC 2002/06

Deborah S. Clarke

August 2002

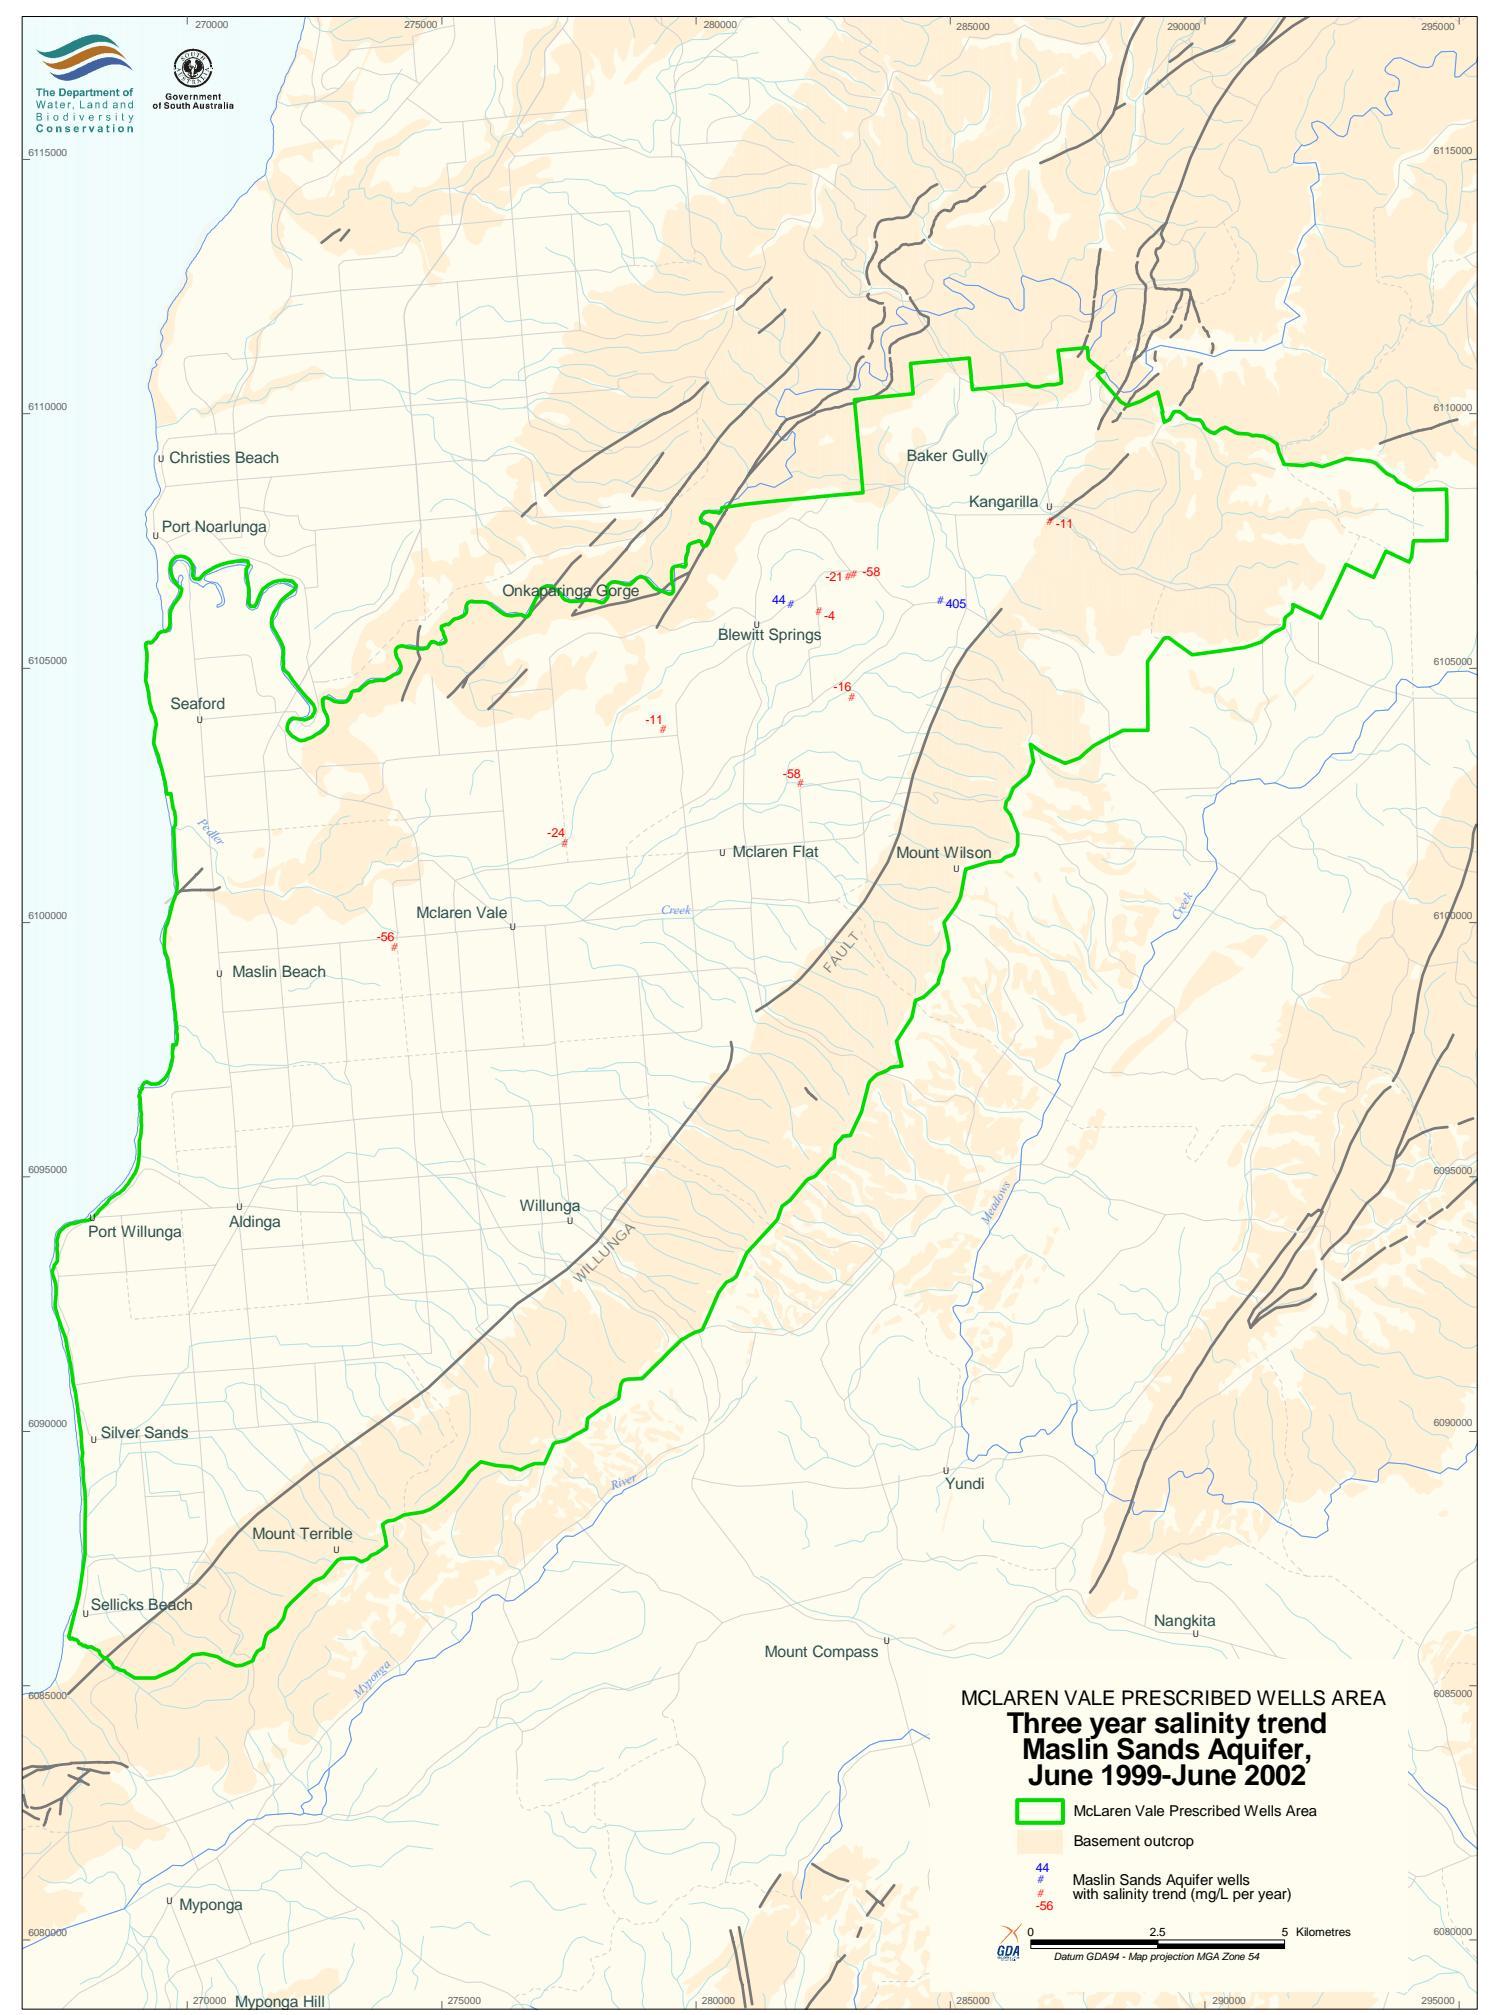
All wells except KTP 18 (6627-7395) and WLG 75 (6627-7631) are displaying a negative trend (Fig. 23), showing that the salinity values have decreased. WLG 75 has an increasing trend but is not considered to be stressed. However, KTP 18 is displaying a trend of 405 mg/L/y over the last three years and is therefore considered a stressed area. Licences wishing to transfer water allocations into this area to draw from the Maslin Sands Aquifer will be restricted.

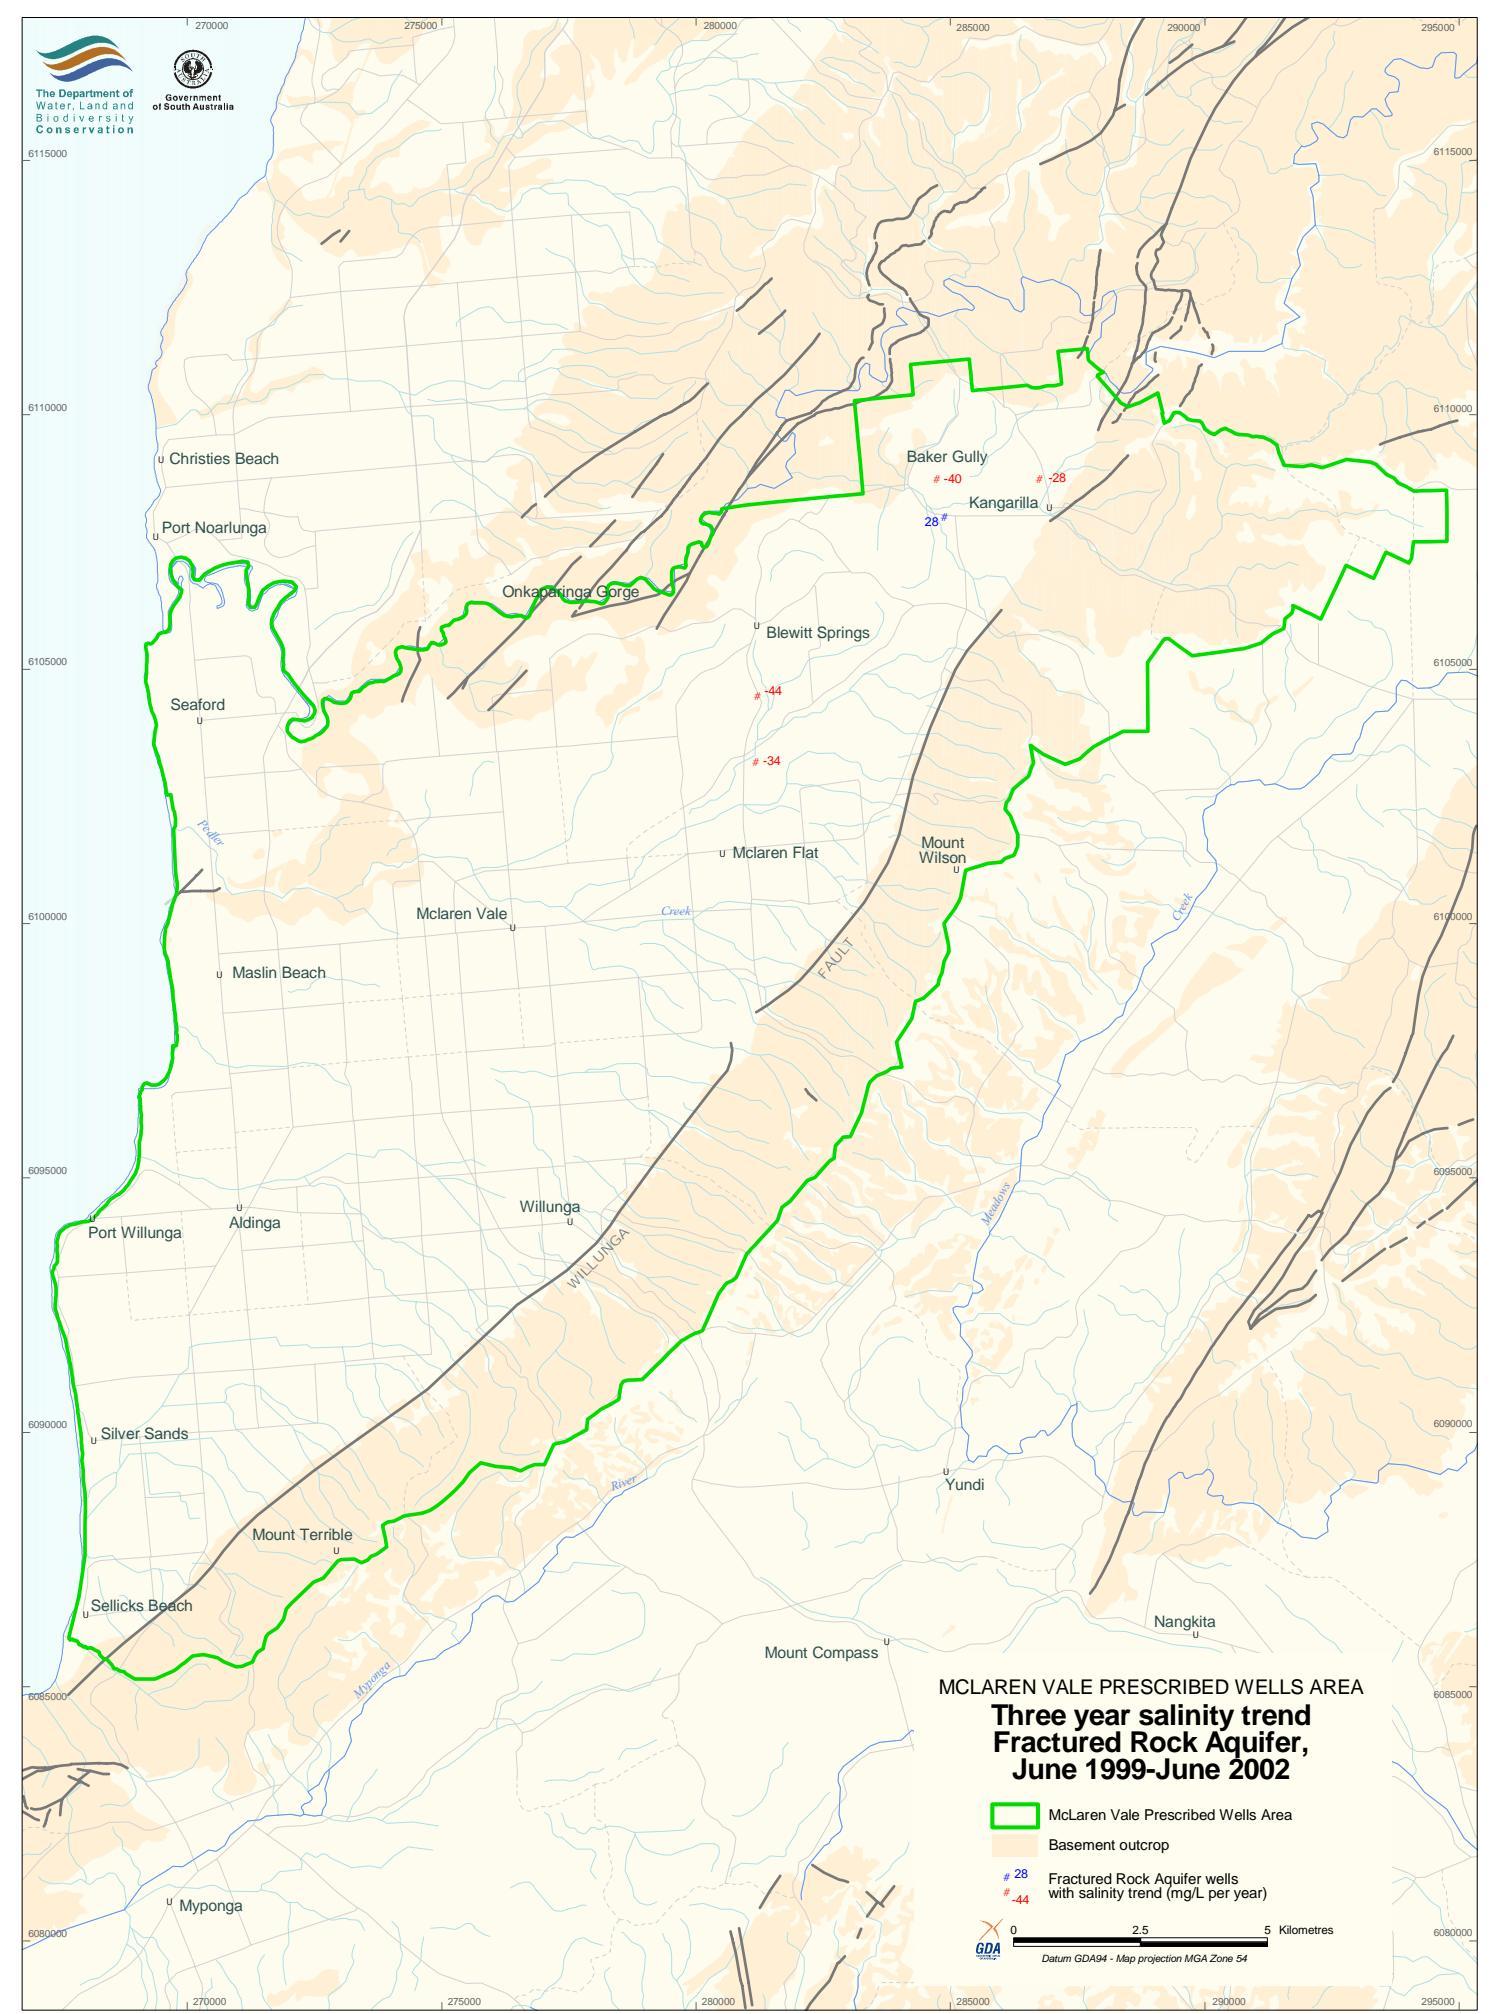
All wells are displaying a stable to a decreasing salinity trend (Fig. 24). KTP 26 is displaying a positive trend but is not considered to be stressed.
