Natural building stones of Mexico–Tenochtitlán: their use, weathering and rock properties at the Templo Mayor, Palace Heras Soto and the Metropolitan Cathedral

Wanja Wedekind · Joerg Ruedrich ·
Siegfried Siegesmund

Abstract In the Aztec period and in colonial times different natural stones originating in the Valley of Mexico were used for building construction. Stone weathering was investigated onsite at various historical buildings within the old quarter of Mexico City. In this study, different aspects of weathering and deterioration at three significant historical buildings will be presented, the Aztec excavation site Templo Mayor, the Metropolitan Cathedral, and the colonial palace of the dukes of Heras Soto. Petrophysical properties of the main building stones of these structures were investigated like density, porosity, pore radii distribution, water uptake rate and coefficient, thermal and hygric expansion, and the mechanical properties of uniaxial compressive strength. A relationship between single critical property values, according to anisotropy fabric characteristics, and specific weathering forms could be deduced.

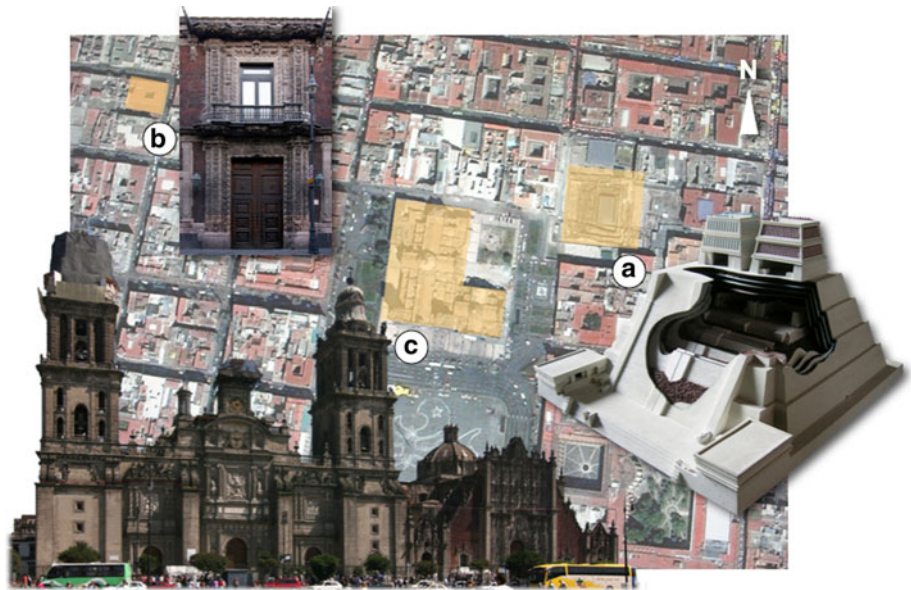
Fig. 1 The investigated buildings within the historical center: *a* location and model of the Templo Mayor, *b* the palace of the dukes of Heras Soto and *c* the Metropolitan Cathedral with the left tower under restoration

The Templo Mayor was one of the main temples of the Aztecs in their capital city of Tenochtitlán, which represents Mexico City today. The temple is located in the center of the historical town and was once the central part of the ceremonial center of Tenochtitlán. The Templo Mayor was originally a towering pyramid topped by two sanctuaries (Fig. 1a). The outline of the temple measuring approximately 100–80 m at its base dominated a sacred precinct. The construction was based on hundreds or even thousands of fence-post-sized supporting piles within the porous marshy terrain to stabilize the building (Sanders 2008). Construction of the first temple started around 1324. The sixth and last rebuild took place in 1487 (Parker 1995) (Fig. 1a). In 1521, the Spanish systematically destroyed the temple.

The Palace of the dukes of Heras Soto was built during the period, 1753–1760, and was the representative domicile of Adrián Ximénes de Alendral, a rich tradesman for silver (Fig. 1b). The name given to the palace-like residence was because of its aristocratic inhabitant in the nineteenth century (Demm 1991). The building in style and construction is a typical exponent of the baroque colonial palace in Mexico City. The residence is nearly 40 by 40 m

Beside tezontle, recinto, and tenayocátetl, the most dominant building stone is “cantera” Gris de los Remedios (III). The ornamental sculpture of the facade is made from these devitrified tuffs (Fig. 1b).

The Metropolitan Cathedral of Mexico City was constructed from 1573 to 1813 on the former Aztec ceremonial center. The cathedral is the largest and oldest in the Americas (Fig. 1c). The cathedral facades are oriented to the south and are approximately 54.5 m wide and 110 m long. The two bell towers were constructed in the latter half of the eighteenth century. The building combined different architectural styles like the Baroque, Neo-Renaissance, and Neo-Classic.

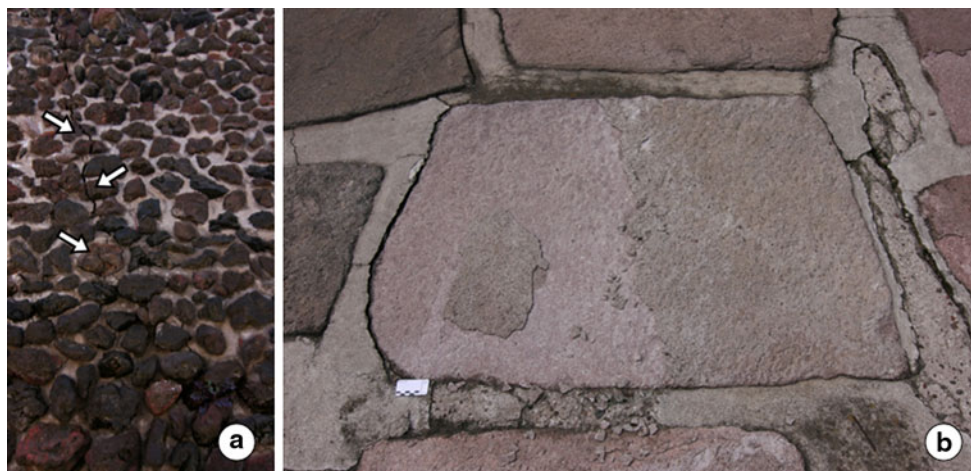
Fig. 2 **a** Structural cracks observable in the tezontle (*arrows*) and **b** scaling of tenayocátl plates parallel to the surface

While the most recognizable deterioration in the tezontle consists of fractures and cracks (Fig. 2a), the weathering feature observable in the tenayocátetl is a scaling parallel to the surface with a thickness of 2–5 mm (Fig. 2b). Both weathering forms are specific for each single type of stone. Especially in the case of the tenayocátetl, the damages are observable on plenty of plates in the platform. In this study, tezontle from a quarry in the state of Mexico, which is used for plenty of restoration works today and the tenayocátetl from the Templo Mayor has been investigated.

In tezontle, crack formation is also detectable because of the improper masonry mortar (Fig. 2a, Sagarra Lagunes 1993), where the Young's modulus is potentially to high according to the moderate values for tezontle of 5.73 kN/mm^2 (Table 4).

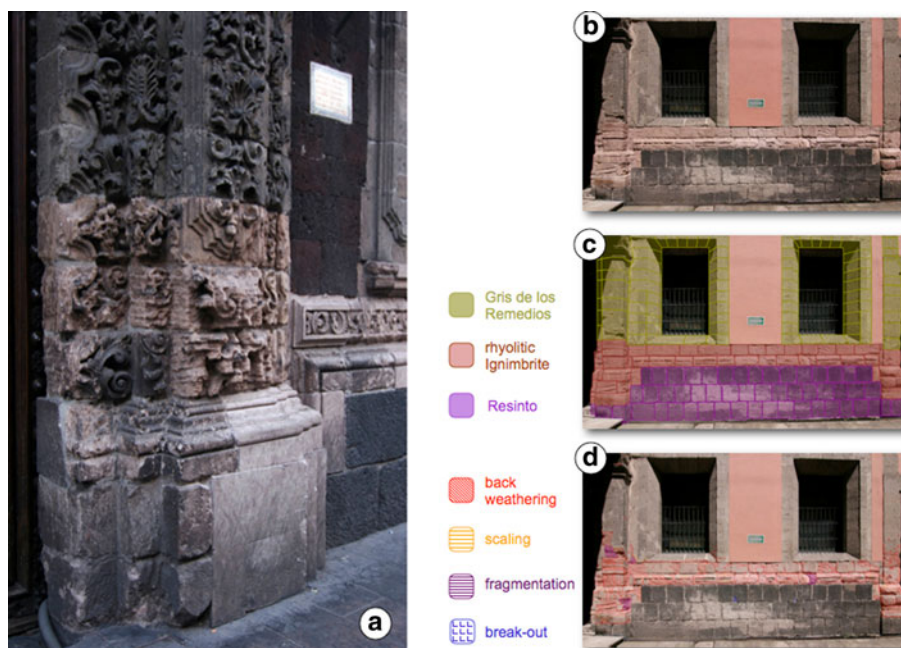
Fig. 3 **a** Weathered and replaced building stones at the ground level, **b** Mapping area, **c** lithographic mapping, **d** Mapping of damages

Weathering can be recognized in the basement area of the building, especially where the sunlit façades are affected by deterioration (Fig. 3a). In the case of this colonial building, the material of the tenayocátetl variety is used as building blocks, mostly horizontal to the flowing structure, which means the bedding or flow structure is observable.

recognized. This part of the building is affected by wet–dry conditions (Fig. 3c).

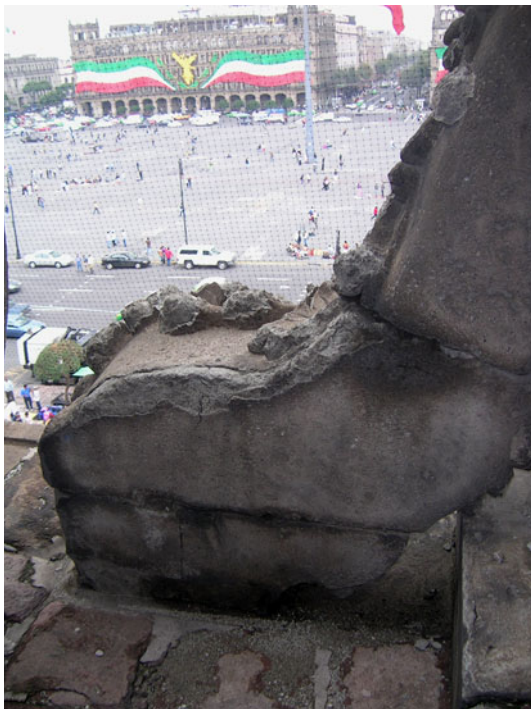
Fig. 4 Crust formation, scaling and rounding of a sculpture at the Metropolitan Cathedral

this study, we focus on these building materials because of their significant weathering features and because of their importance as historical building material. The pyroxene andesite of the Metropolitan Cathedral shows a typical weathering form starting with crust formation, and then scaling due to flaking and rounding (Fig. 4).

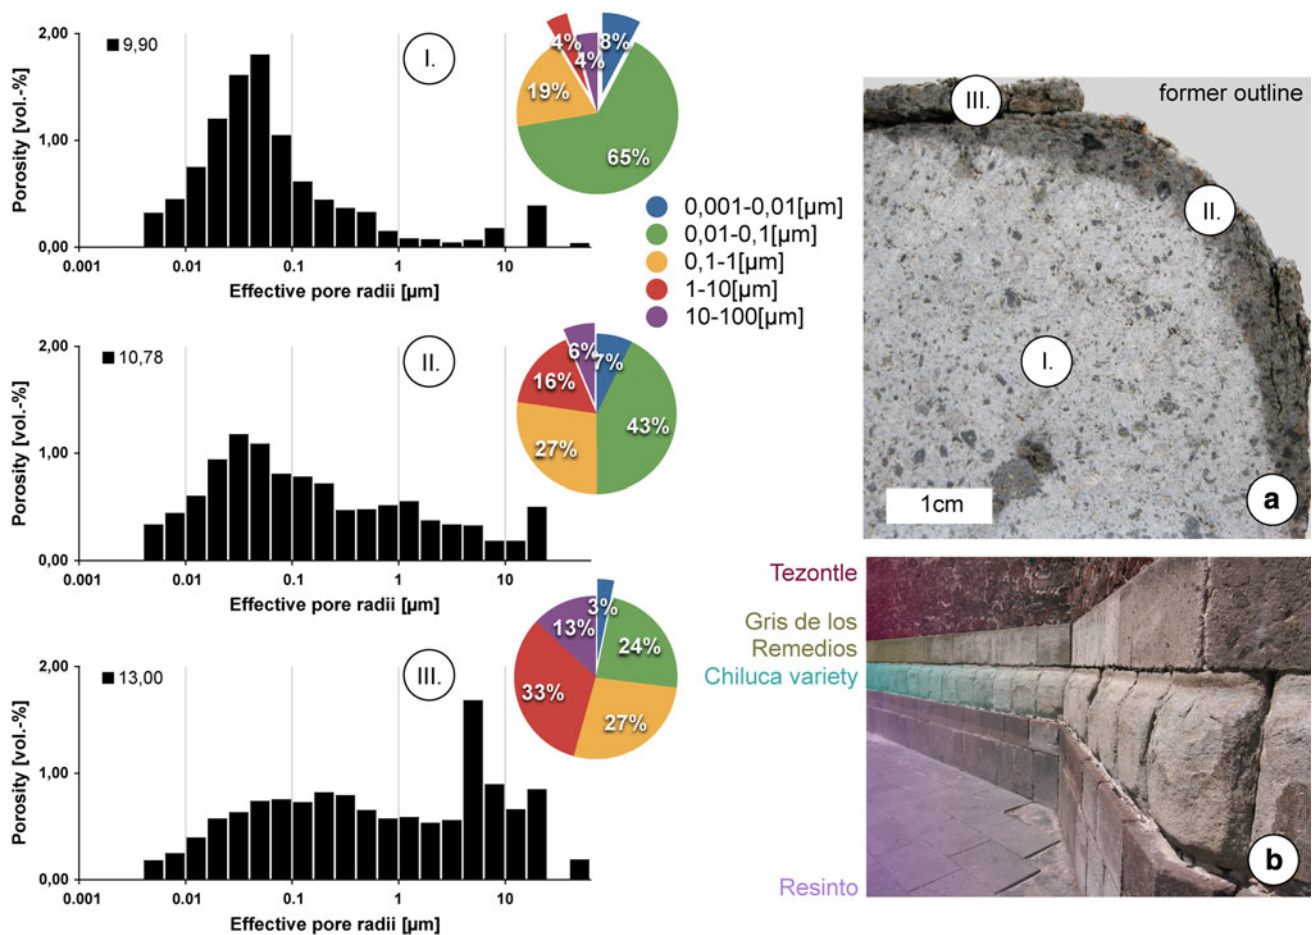
Fig. 5 **a** Truncated stone sample of pyroxene andesite from the Metropolitan Cathedral. I, II and III depict changing pore radii distributions according to the different zones of weathering. **b** Rounding in the Chiluca variety

During the process of weathering, the first centimeter of the stone material is especially affected. Thus, the pore radii distribution, porosity, capillary water uptake, and hardness change. Tests conducted in the laboratory with this weathered material clearly demonstrated this process. After the moistening of a truncated stone sample, the water penetrates and remains in the weathered zone only (Fig. 5a). Here the pore size contribution changes for the benefit of a higher amount of capillary active pores from 27 to 76% in comparison to the unweathered material (Fig. 5I–III). Capillary active pores are defined as those having a cross-sectional dimension ranging from 0.1 to $>100\ \mu\text{m}$ (Klopfer 1985). Porosity increases from 10 to 13% (Fig. 5I–III), whereas the surface hardness measured with a durometer DO (ASTM D 2240), decreases down to 70% in comparison to the intact material.

Today the outlines and sharp edges of cut stones often are back-weathered. These weathering processes take place especially in the pedestal area (Fig. 5b) or in building parts, which are exposed to rain and down flowing water.

New mining methods at the beginning of industrialization (late eighteenth century) created means for excavating large amounts of the phenocrystic andesite for the cathedral's main facade and bell towers. Before this time these types of andesites were normally used for the construction of the ground floor and pedestal areas. Both building parts, the bell towers as well as the foundation zones are affected by wet–dry conditions. In the phenocrystic andesite the limited depth of weathering seems to be connected to the low w -value measured in both varieties (Table 2). Chiluca contains a low porosity; the w -value is a little higher than the original material of the cathedral (Table 2). This is due to the different pore radii distributions in both varieties. The active capillary pore space of Chiluca accounts for 73.2%, whereas the original material of the cathedral only attains a value of 37.6% (Table 1). During a water uptake of 4 h, suction of only 0.5 cm could be determined. This correlates with the depth profile of weathering and crust formation (Fig. 5).
