# Development and assessment of protective winter covers for marble statuarities of the Schlossbrücke, Berlin (Germany)

**Abstract** The present study documents the results of an inter-disciplinary model project that was planned with the aim of developing an innovative winter covering system for marble statuarities located on the Schlossbrücke (Berlin). Such a system would need to fulfil the various requirements for structural stability, aesthetics, climate and practical use. This applied research represents the first complex scientific study of the sustainability of a winter covering system. The study is characterised by the use of complex scientific instruments such as special laboratory analysis and numerical simulation tools. The interaction between the environment and the artefacts in connection with the innovative winter covering structures were studied by extensive climatic monitoring.

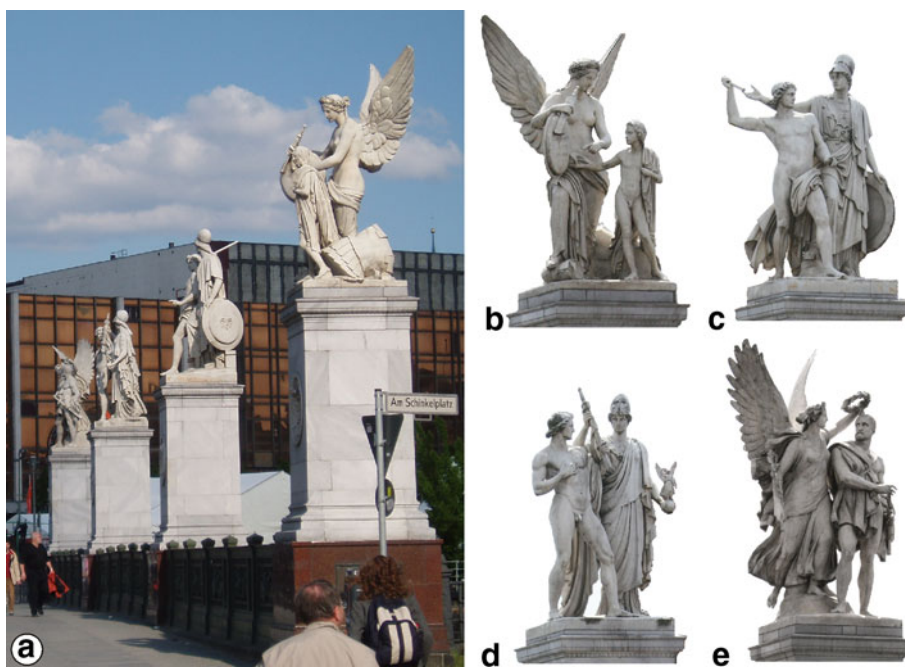
**Fig. 1** Schlossbrücke, Unter den Linden/Berlin: **a** Marble statuary ensemble on the southern side; **b** Sculpture group 1 “Nike educates the boy in history” by Emil Wolff, 1847; **c** Sculpture group 2 “Athena teaches the young man how to use a weapon” by Hermann Schiavelbein, 1853; **d** Sculpture group 3 “Athena arms the warrior” by Karl Heinrich Möller, 1851 and **e** Sculpture group 4 “Nike crowns the hero” by Friedrich Drake, 1853

The “Schlossbrücke”, with its monumental sculptural groups made of Carrara marble, is situated in the centre of Berlin on the edge of the Museum Island, a UNESCO world cultural heritage site (Fig. 1a). As a result of their eventful history and exposure to the elements, these sculptures now show considerable signs of damage. The most significant deterioration is caused by thermally induced microcrack formation, which is characteristic of many marble types. For Carrara marbles this decay is expressed as a penetrative granular disintegration. Progressive fabric decohesion leads to a sugar-like crumbling of isolated calcite crystals on the sculpture surfaces. A subordinate relief structure can be observed, which is caused by chemical solution processes close to the surface. In spite of numerous restoration attempts, significant dirt is still observable on the figures. This probably results from the high traffic volume (32,000 vehicles per day) along the boulevard Unter den Linden. Gaseous compounds, solid dirt particles such as soot, fine particles, rubber particles and microbiological colonisation are the main causes of the soiling and the pollution on the surfaces of the statues. Remedial action is essential and necessary for preserving these high quality sculptures as a historical ensemble.

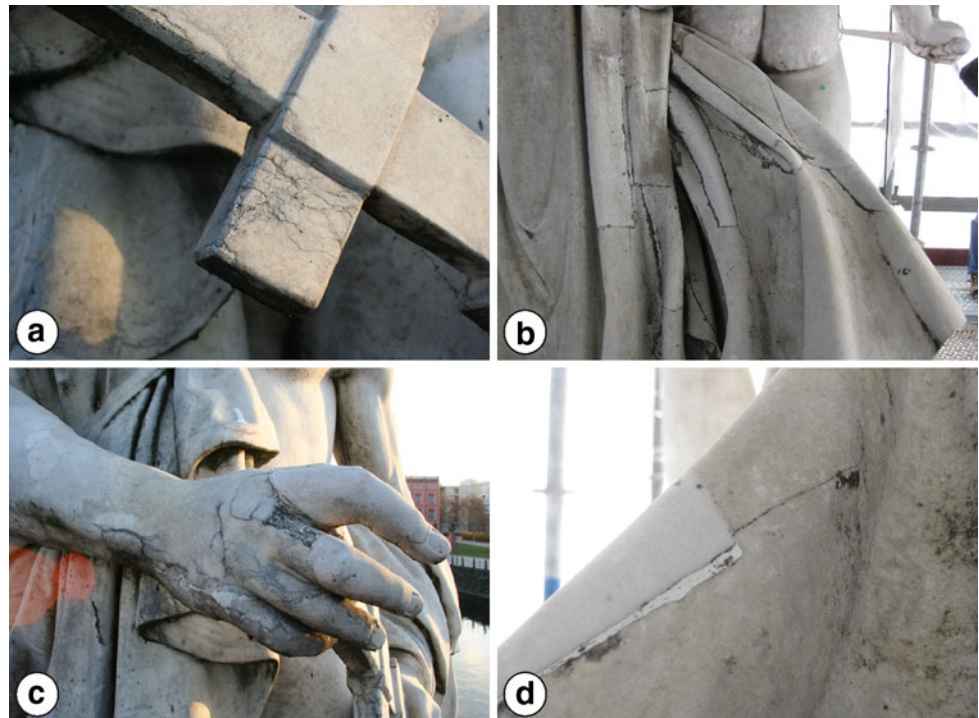
**Fig. 3** Main macroscopic damage phenomenon: **a** intensive cracking, **b** replacements, **c** complex cracking with break-outs and **d** new distinct crack growth starting from an older replacement

Due to their long exposition time and diverse history, the marble sculptures show various types of decay phenomenon (Fig. 3). The macroscopic damages are characterised by a few replacements of filigree body parts, e.g. substitutions for fingers, hands, wing parts, etc. Moreover, the original marble locally shows a pronounced surface

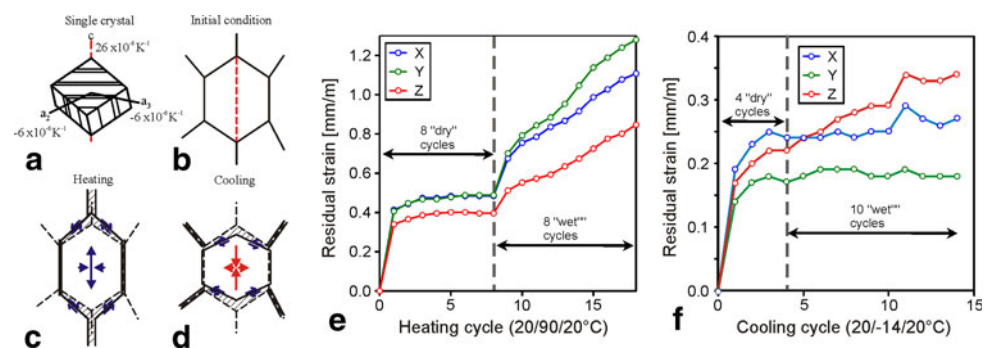
**Fig. 5** Marble deterioration: **a** Thermal dilatation coefficients of the calcite single crystal with respect to the crystallographic orientations, **b** schematic illustration of a calcite crystal at initial conditions,

**c** volume change by heating and **d** by cooling, **e** progressive residual strain under dry and following wet conditions induced by heating and **f** by cooling measurements

directions (Kleber 1959) leading to stresses within the sample during heating (Fig. 5a–d). When these stresses exceed the threshold of cohesion, a thermally induced deterioration is observed (cf. Sage 1988; Weiss et al. 2002, 2004). The rock fabric, which includes grain size, grain aspect ratios, grain shape preferred orientation, lattice preferred orientation (texture) and the microcrack populations, significantly controls the material's behaviour during thermal stress (e.g. Siegesmund et al. 2008; Shushakova et al. 2010).

the same sample size. For the first dry cooling cycle a strong residual strain also occurs (Fig. 5f). In the experiment the residual strength is the half compared to heating. But also the absolute temperature difference was the half. Thus, in the initial dry thermal deterioration the residual strain is a function of the absolute temperature difference. For the further dry loading cycles a slight increase of residual strain is detectable, which is also comparable to the heating situation. In contrast to the dry behaviour, the cooling of wet samples only shows a slight increase of residual strain. This implies that for the investigated samples freeze–thaw action only plays a secondary part. Other experiments have shown that if cracks are open to a certain extent, the capillary water uptake increases and weathering processes like chemical solution or freeze–thaw action plays a more important role for marble decay (Ondrasina et al. 2002; Ruedrich 2003).

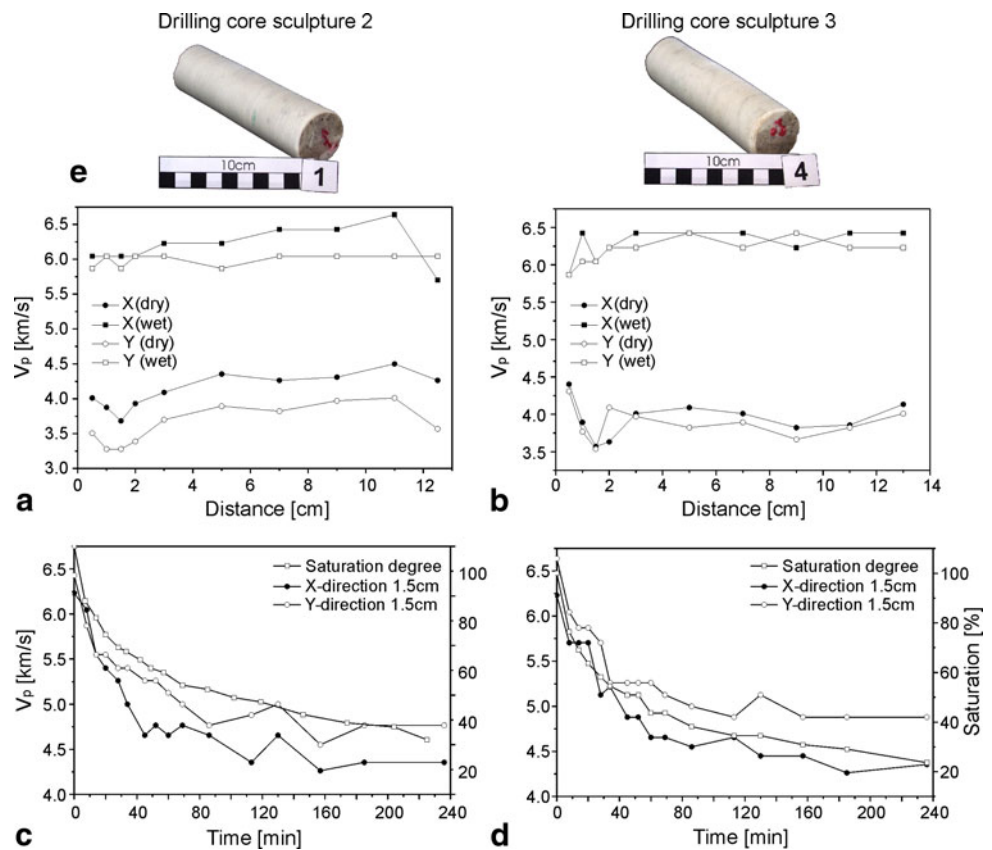
**Fig. 8 a, b** Ultrasonic wave velocities ( $V_p$ ) of drilling core 1 (sculpture group 2) and 4 (sculpture group 3) in a depth profile at dry and water-saturated conditions. **c, d** Correlation between  $V_p$  and water saturation, **e** drill cores

The measured ultrasonic velocities at dry sample conditions are between 3.25 and 4.50 km/s (Fig. 8a, b). The

mean value is around 3.90 km/s, which can be designated as increasingly porous after the classification by Köhler (1991). At water-saturated conditions,  $V_p$  varies between 5.80 and 6.60 km/s and are characteristic for Carrara marbles (Fig. 8a, b). Water-saturated weathered marbles are known to show nearly the same  $V_p$  properties as the original values with fresh conditions (e.g. Weiss et al. 2000; Siegesmund et al. 2009).

The  $V_p$  distribution along the depth profile at dry sample conditions for drill core 2 exhibits conspicuous changes. Near the surface, a relatively high  $V_p$  of 4.75 km/s is detectable. At about 17 mm, depth  $V_p$  is strongly reduced to 3.60 km/s and increases with depth up to 4.00 km/s. The same pattern can be determined for the second drill core but the  $V_p$  changes are less pronounced. Commonly  $V_p$  should be the lowest near the surface because weathering intensity is highest at the surface. This indicates a secondary fabric stabilisation of areas close to the surface. The cause could be chemical solution/precipitation reactions or former consolidation works.

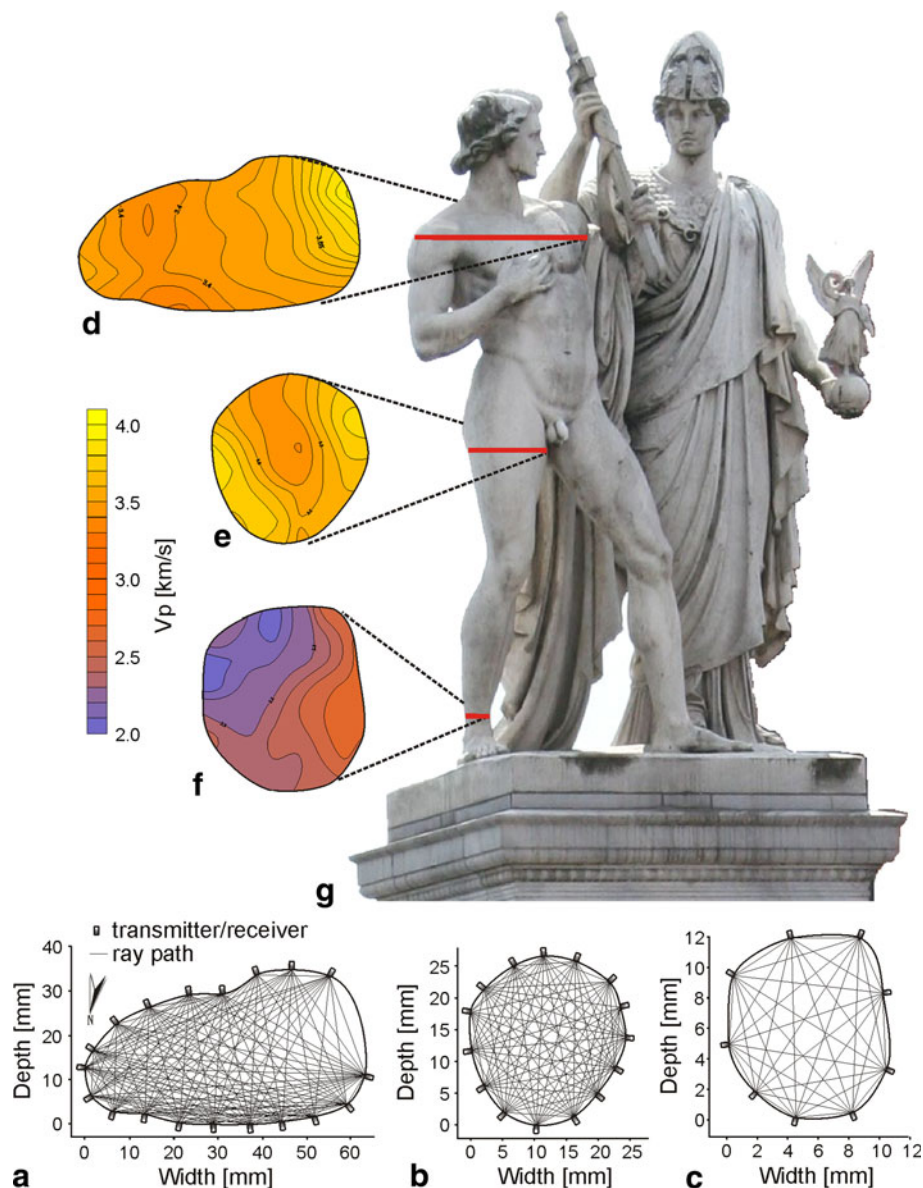
**Fig. 9** Tomographic reconstruction of three profiles for sculpture group 3: **a–c** transmitter/receiver positions and associated ray paths, **d–f** tomographic inversions

To detect the damage of the rocks interior, detailed two-dimensional tomographic investigations with ultrasound (250 kHz) were carried out on-site. The results of sculpture group 3 are given in Fig. 9. Measuring points are defined in order to achieve a tight grid of measuring tracks for each profile (Fig. 9a–c). The analyses were carried out at three different horizontal slices at the shoulder (profile I), the thigh (profile II) and the shackle (profile III) of the warrior. For better signal transmission, a special clay was used between the transmitter and the marble. The calculations of the tomographic inversions were compiled with the programme Migratom (cf. Jackson and Tweeton 1994; Ruedrich et al. 2001; Siegesmund et al. 2009).

For the chosen example the ultrasonic velocities in the tomographic profiles vary between 2.0 and 4.1 km/s. The lowest velocities are observable for profile III between 2.0 and 2.8 km/s. This indicates that the smaller sculpture parts are strongly deteriorated than the voluminous parts, and is in agreement with the macroscopic damage observations.

The velocity distribution patterns are different for all profiles (Fig. 9d–f). For profile I and III, the areas of lower velocity are exposition-controlled. More deteriorated parts are non-protected by other sculpture parts, and thus subjected to stronger weathering. Profile III shows a low velocity channel from southeast to northwest. Since the  $V_p$  differences are low, this velocity pattern may only be affected by the marble anisotropy. Ruedrich (2003) found an increasing  $V_p$  anisotropy up to 30% for Carrara marbles with progressive fabric decay. Comparable ultrasonic velocities in intensity as well as in its distribution pattern are observable for all sculpture groups of the Schlossbrücke.

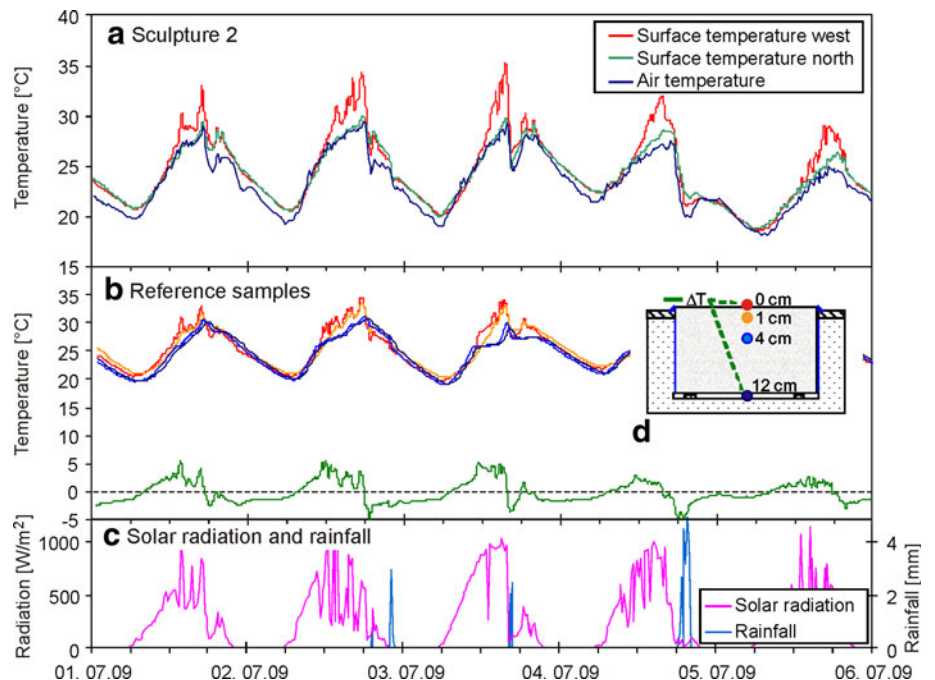
**Fig. 11** Influence of the microclimate on the marble temperatures in summer:  
**a** temperatures measured at sculpture group 2,  
**b** temperatures in a depth profile from a reference sample with one exposed surface, **c** solar radiation and rainfall and **d** exposed reference sample with temperature sensors at different depths

temperatures of the massive parts of the sculptures on the south and north side. Figures 11a and 12a show examples for measured surface temperatures on sculpture 2 in comparison to the air temperature. In winter, the highest temperatures were measured on the south side of the sculptures, where the influence of direct solar radiation is the highest. In the period shown in Fig. 12a, the differences of the surface temperatures on the north and on the south side of the unprotected sculpture are lower than 4°C. Without direct solar radiation, no temperature difference can be seen. Moreover, the increase of the surface temperature by solar radiation in the summer is not very high. In the period investigated, the highest temperatures were measured on the west side. The maximum temperature difference between the north and the south side is below 6°C. The maximum surface temperature difference since the beginning of the measurements is below 10°C.

southwest (Fig. 11d). The other surfaces of the reference sample exhibit a heat insulation in order to evaluate the thermal behaviour of massive sculpture parts. As expected, the development of the surface temperature in general equates to the temperature profile measured on the west side of sculpture 2. Due to the high thermal conductivity of the marble, the temperature at a depth of 1 cm follows the surface temperature fast. Higher surface temperatures only occur in times of direct solar radiation. In the period from the 1st to 6th July 2009, the highest temperature difference between the surface and the backside of the sample is about 5°C (Fig. 11b). If the environmental temperatures rise, the surface temperature is always the highest. The temperature profile is inverted, if the ambient temperature drops.

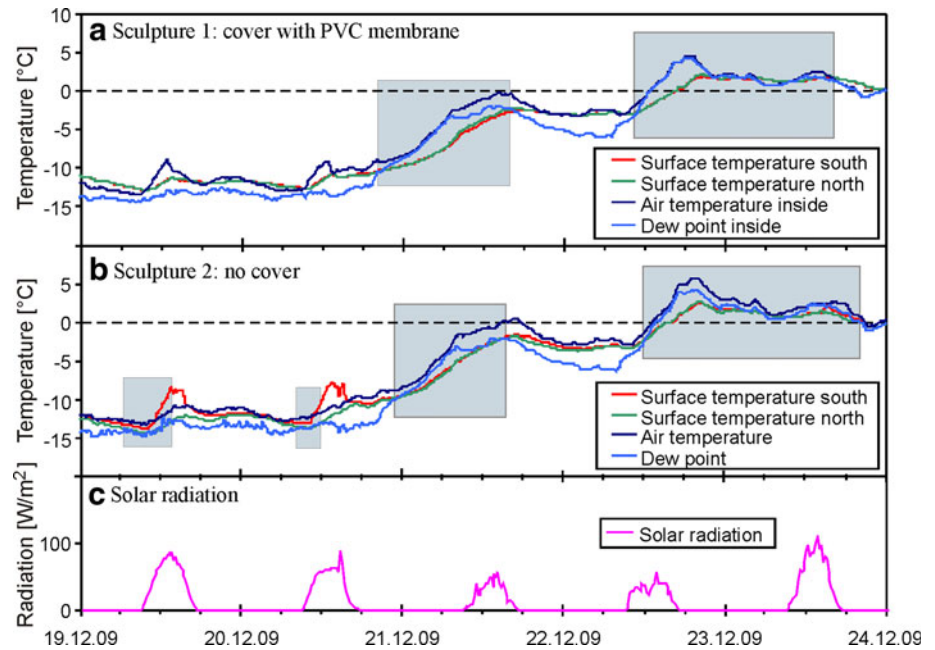
**Fig. 13** Influence of climate and the cover with PVC membrane on the marble temperatures in winter. The pale blue boxes represent periods where the surface temperature falls below the dew point

Inside the membrane cover, the surface temperatures can also fall below the dew point. In Fig. 13, these periods are represented by the pale blue boxes. If the temperatures are below the freezing point, this leads to hoarfrost on the sculptures. Not until the temperatures rise above the freezing point does the surface of the marble get wet. This occurred on the morning of the 22nd of December 2009 as shown in Fig. 13. The surface temperature is still below the dew point.

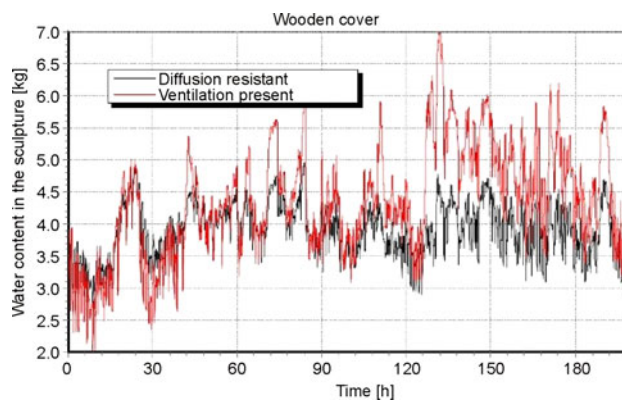
**Fig. 18** Total moisture content of the idealised marble sculpture having wooden protective winter covers. Comparison of an airtight and an open winter cover system with ventilation

In Figs. 18 and 19, different wooden winter covers are compared. To understand the operation of the wooden shelter on the marble sculpture, the mean moisture content of the statue is shown. Relatively airtight constructions lead

to smaller moisture contents in the marble. Assuming hygric and thermal dilatation is proportional to the amplitude of moisture and temperature, the relatively airtight wooden shelter is preferred. The variation of moisture for non- and low-circulating systems is 3–5 kg moisture, whereas air-ventilated systems deliver a variation of 2–7 kg. The daily amplitudes are much larger, leading to substantial dilatation in the marble. In spring time, the daily fluctuations are extreme. During sunny days, warm outside air is laden with moisture and passes over the cold

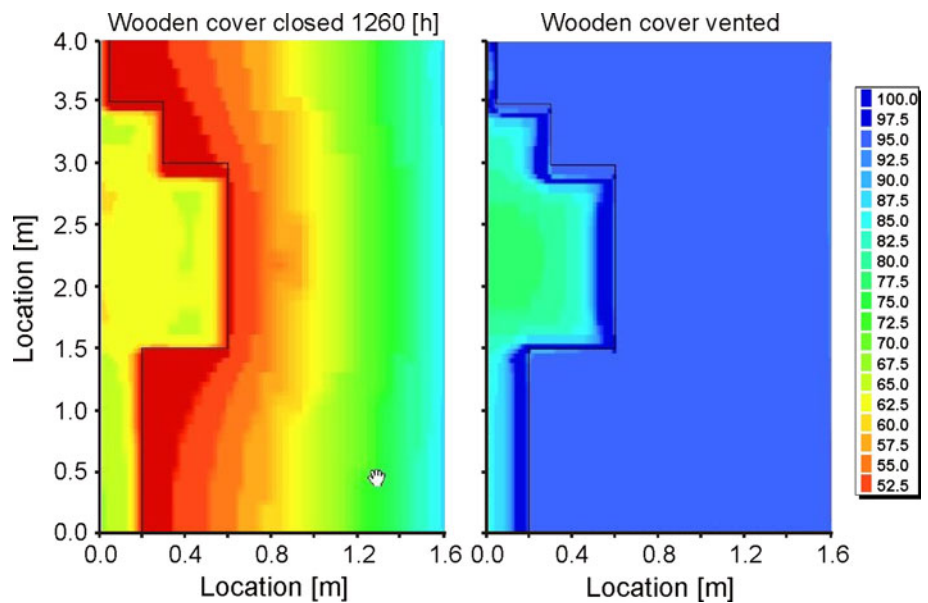
**Fig. 19** Comparison of relative humidity calculated for two wooden protective winter covers in the early spring: relatively tight (*left*) and having air ventilation openings (*right*)

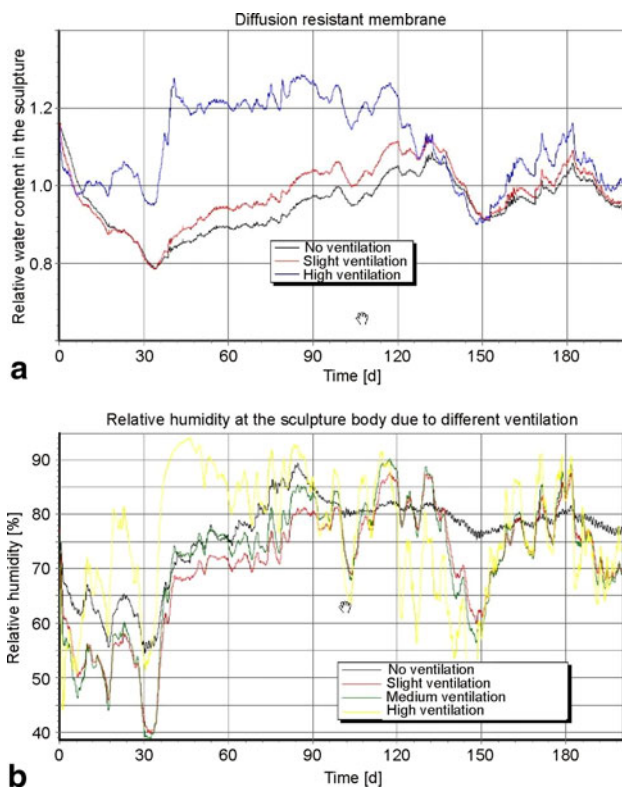
**Fig. 21** Comparison of different membrane protective winter cover systems: **a** no ventilation, small ventilation (base open) and high ventilation (5 Pa pressure difference). **b** Relative humidity at the torso of the sculpture: no ventilation, small (0.5 Pa pressure difference and base open), medium (1.5 Pa pressure difference) and large ventilation (5 Pa pressure difference)

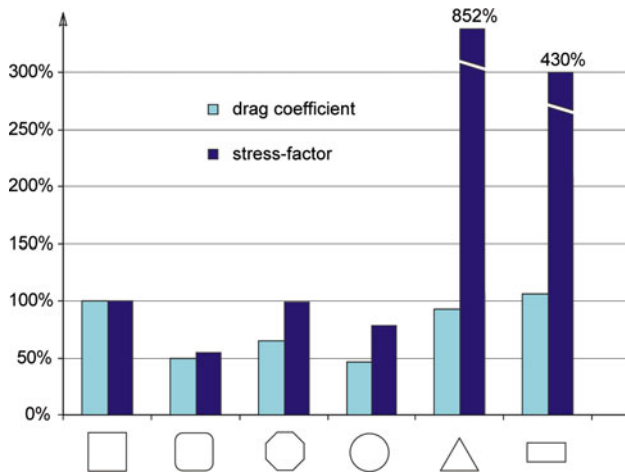
**Fig. 23** Drag coefficient and stress factor (drag coefficient/section modulus) of different geometries

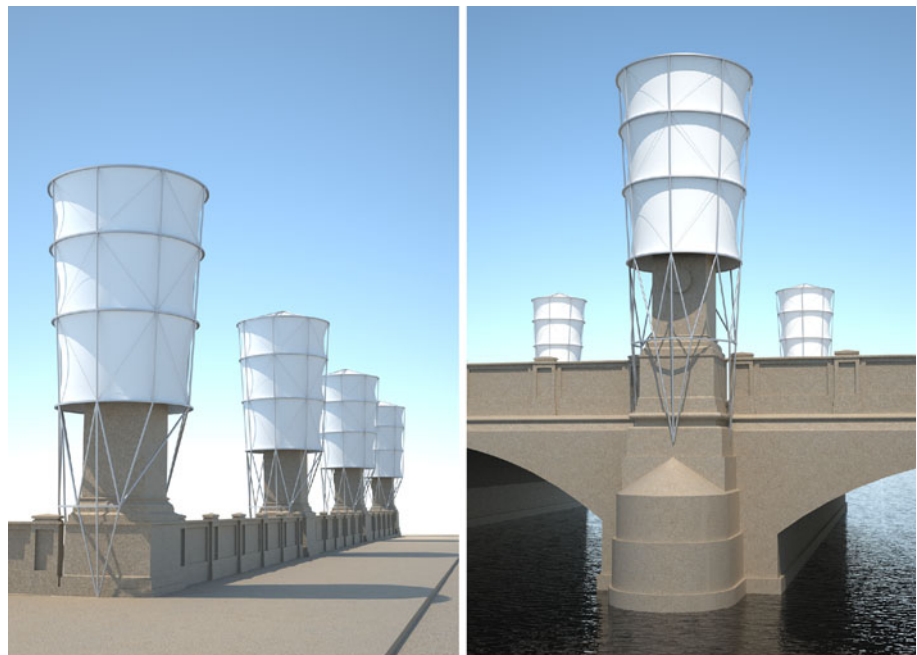
**Fig. 26** View of the shelter systems from the street and river

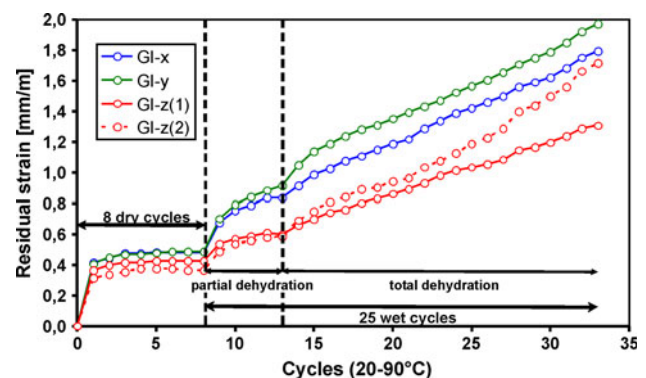
**Fig. 27** Progressive increase of residual strain of a Carrara marble as a function of the number of heating cycles under dry (cycles 1–8) and wet (cycles 8–33) conditions. From cycles 8–14, the samples remain humid; from cycle 14 samples run dry after each cycle. The colours of the curves indicate different directions of the sample reference system
