Delamination Detection on a Concrete Bridge Deck Using Fast Scanning Impact Echo

We use Impact Echo to detect damage on a concrete bridge deck: large scale, fast and reliable

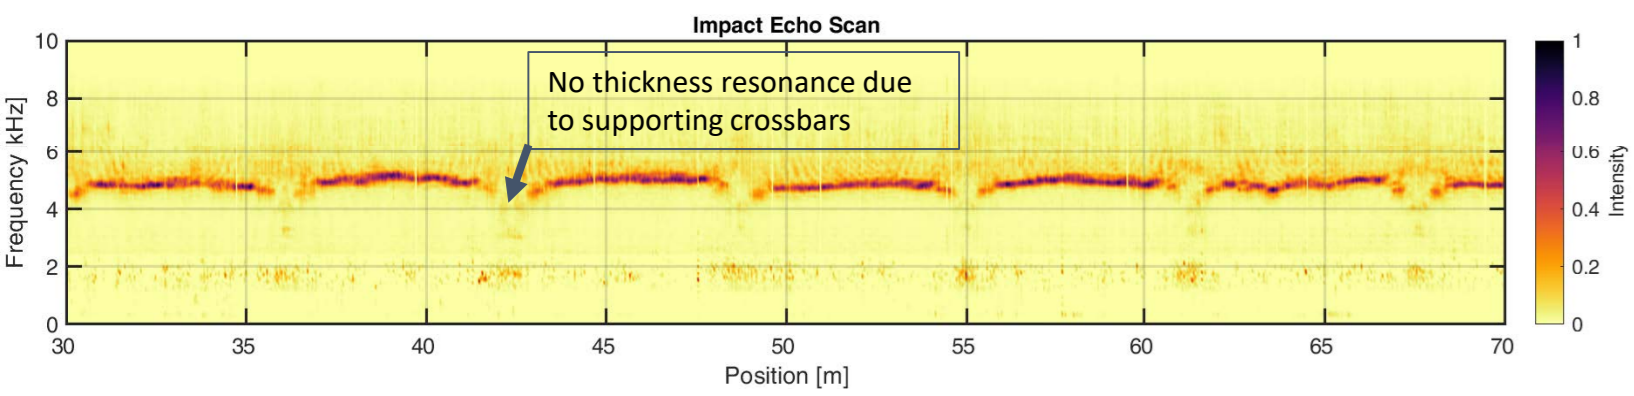
Fig. 1: Impact Echo plot of intact bridge section

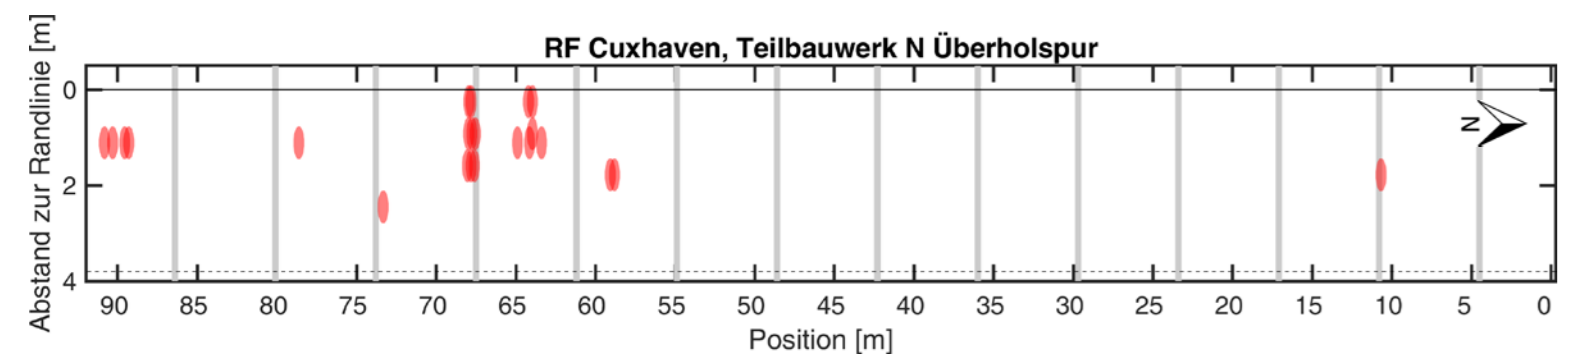
Fig. 2: Bridge section map with delaminations as red ellipses

- More than 17 000 m² scanned
- 932 Delaminations found
- Good bonding of fresh and old concrete can be verified
- Measurements are “fast” and reliable

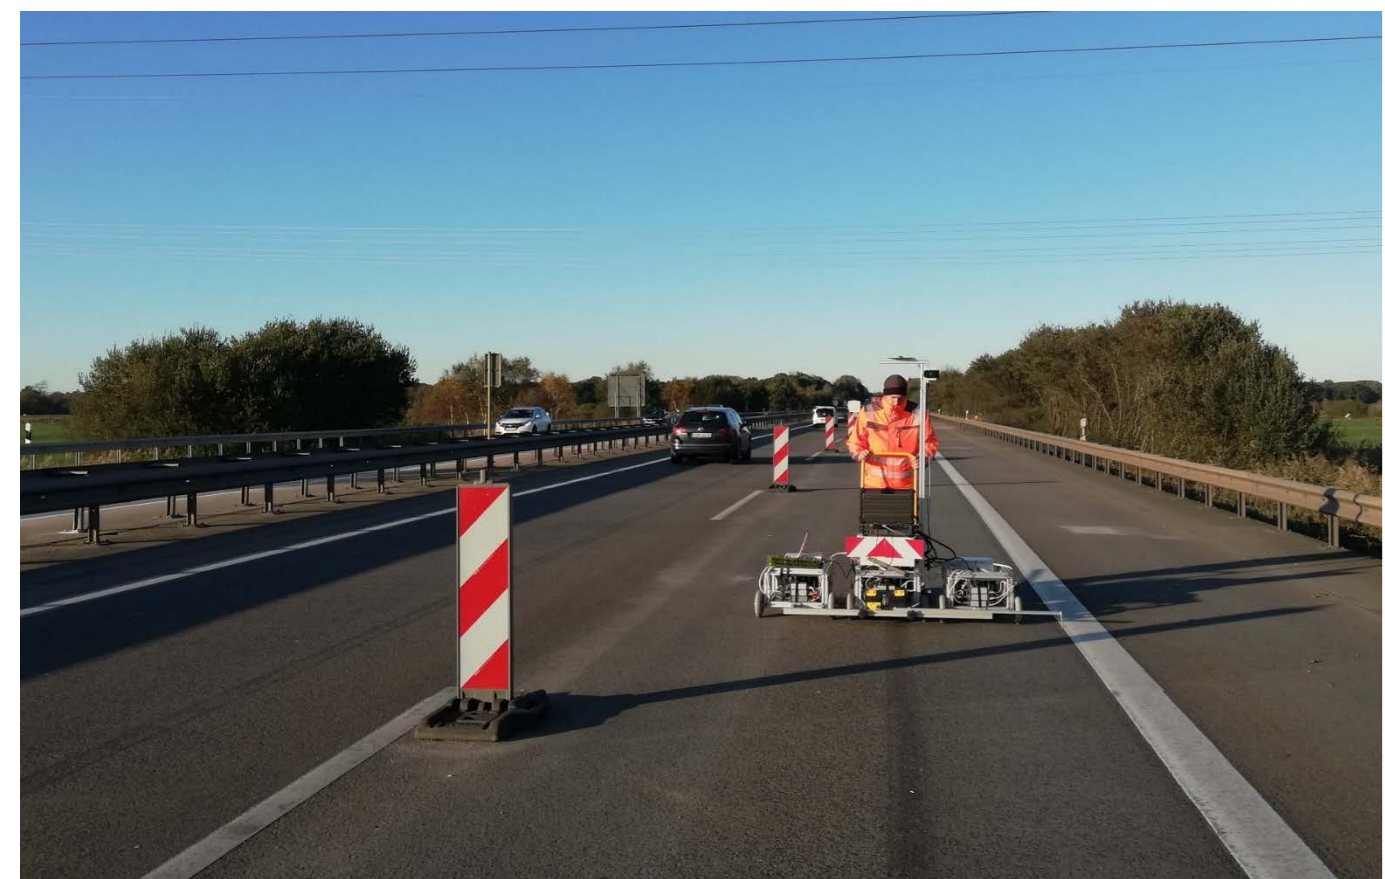
Fig. 3: Scanner being pushed on Moobrücke.

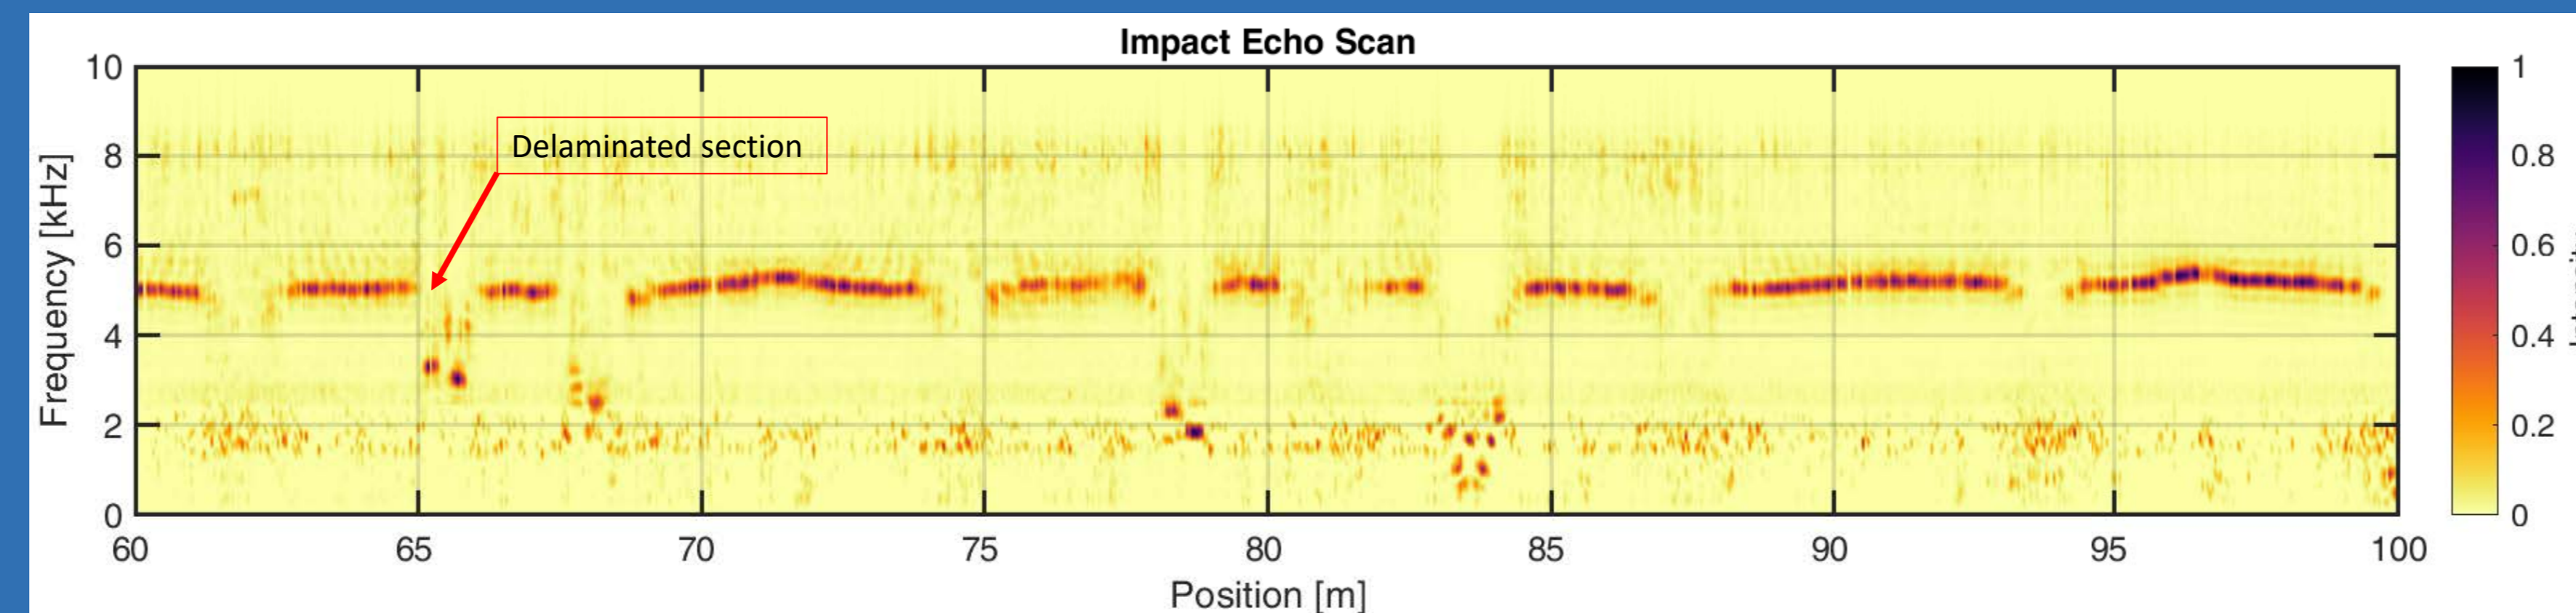
Fig. 5: Impact Echo plot of partial delaminated bridge section
