Constraints of the durability of inorganic and organic consolidants for marble

Johanna Menningen¹ · Enrico Sassoni² · Robert Sobott³ · Siegfried Siegesmund¹

Abstract

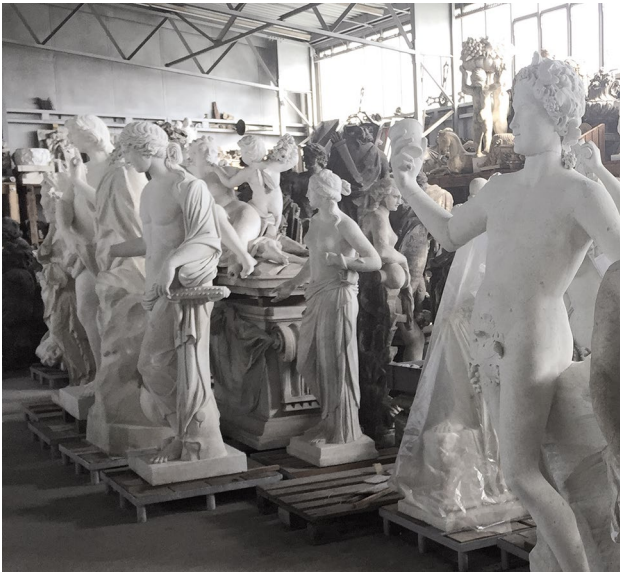
Fig. 1 Storage of fragile sculptures to protect them from ongoing decay, as here in the Sculpture Hall of the Prussian Palaces and Gardens Foundation

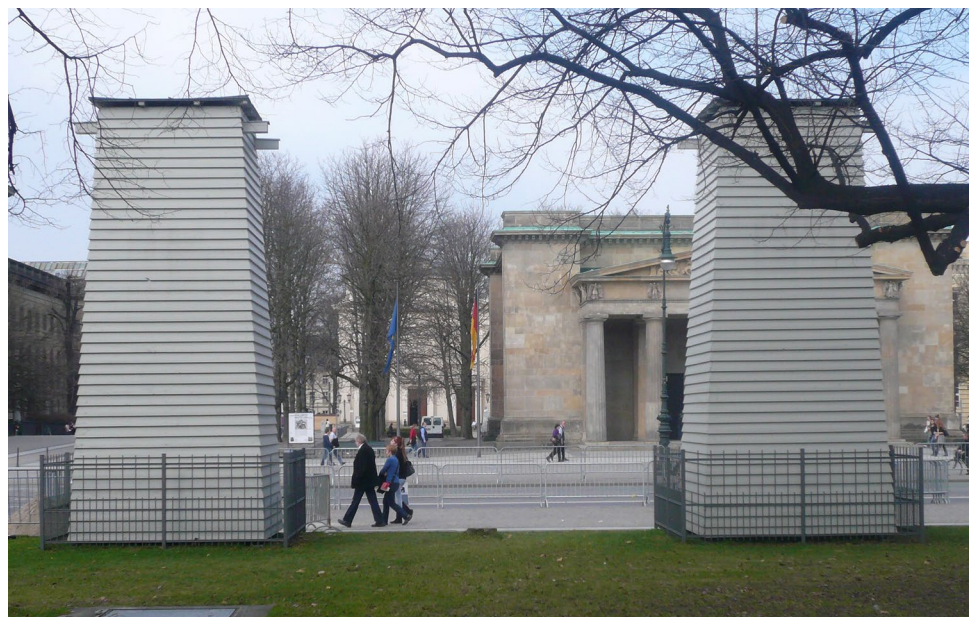
Fig. 2 Monuments of General von Bülow and General von Scharnhorst, sheltering of both monuments at their current location during the winter time to avoid extreme climate condition and its effect on the progressing decay (after Menningen et al. 2020)

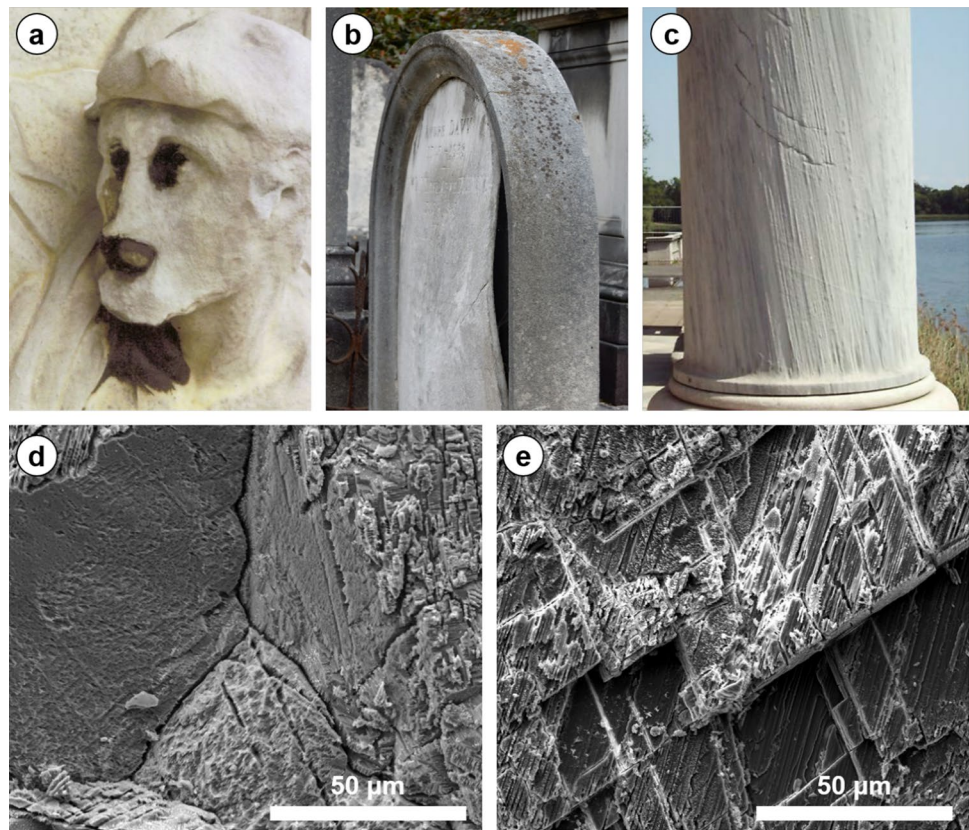
Fig. 3 Examples of marble artifacts subject to black crust formation (a), bowing (b), back weathering and cracking (c) and microscope images of marble affected by crack formation at grain boundaries (d) and surface etching (e)

Marble sculptures and architectural elements exposed outdoors are subject to severe decay, owing to several deterioration processes such as thermal weathering, dissolution due to rainwater and pollutant deposition (Figs. 1, 2, 3).

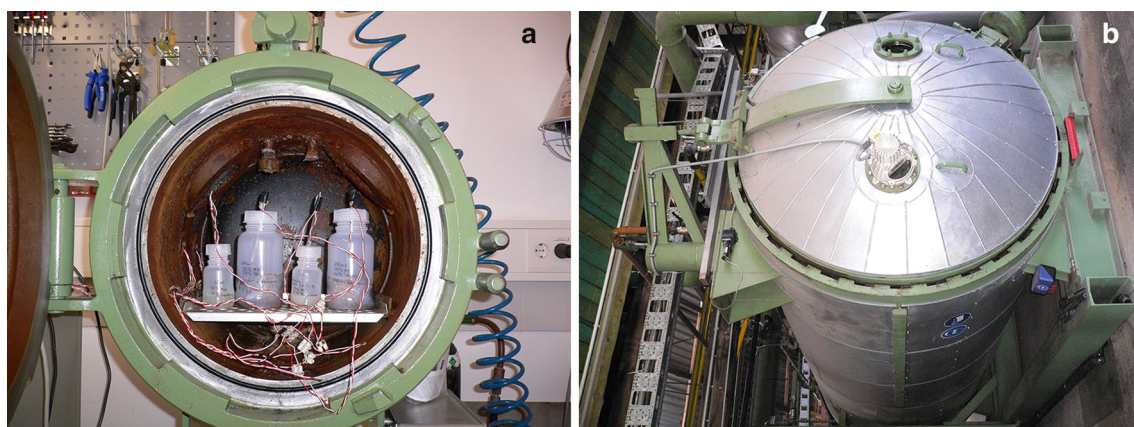
Fig. 4 a Laboratory control of the consolidants prior to the consolidant application b closed autoclave of the AVT full impregnation technology of the JBACH Steinkonservierung GmbH

Before consolidant application (Fig. 4a), cylinders and cubes were artificially aged by repetitive heating. The cylinders were heated to 200 °C, the temperature was maintained for 4 h and subsequently the samples were cooled down to about 4 °C. This cycle was repeated 4 times. The cubes were heated up to 40 °C and then cooled down to about 4 °C, afterwards the temperature was increased step wise to 60 °C, 90 °C, 120 °C, 150 °C and finally up to 200 °C, each step followed by cooling down. So these samples were treated at least 6 times with different temperatures.

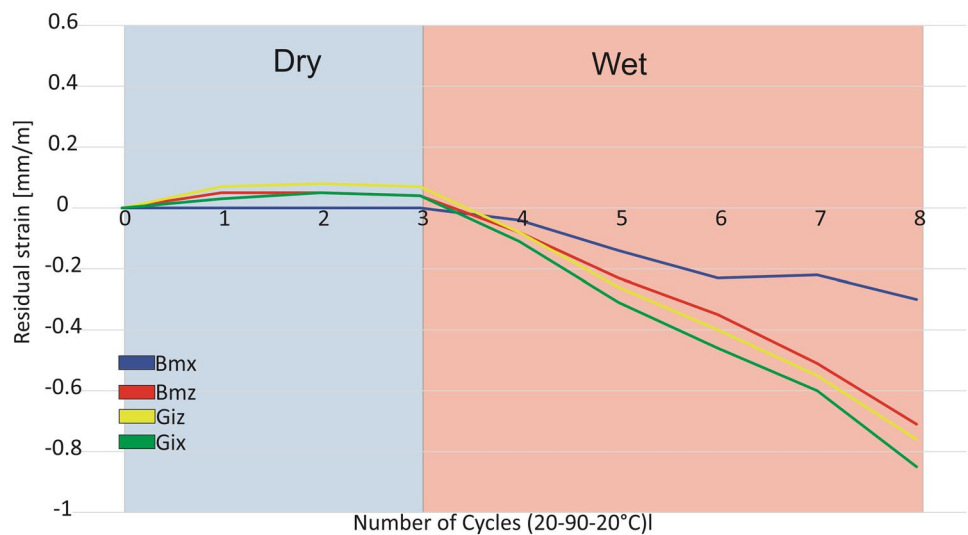
Fig. 10 Residual strain (mm/m) of Blanco Macael and Carrara Gioia in the X- and Z- directions, after treatment with Paraloid B 72, as a function of the number of heating–cooling cycles in dry (3 cycles) and wet (5 cycles) conditions

The residual strain of marbles treated with Paraloid B72 was found to be sensibly increased when water was

present inside the specimens, as illustrated in Fig. 10 for some exemplary conditions. While the dry cycles caused limited residual strain, the presence of water in the pores caused the Blanco Macael and Carrara Gioia to shrink and reach values of almost -0.9 mm/m after 5 wet cycles. This phenomenon can be attributed to a collapse of the marble-resin system (Ruedrich et al. 2002), favored by the T_g of Paraloid B72 and by the presence of water.

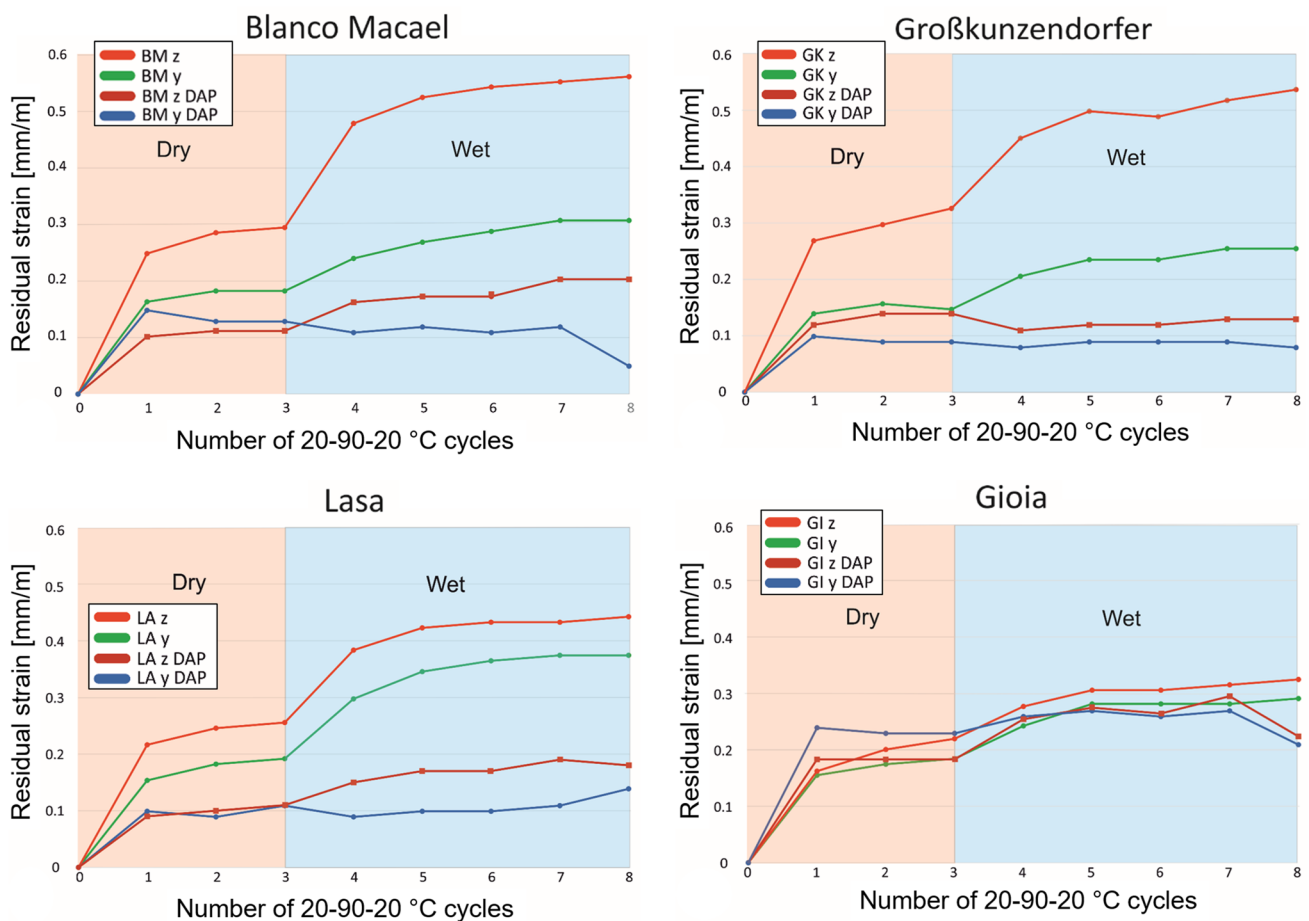
Fig. 11 Residual strain (mm/m) of the four marble varieties, untreated and DAP-treated, in the directions with the highest (red curve) and the lowest (green curve) residual strain, as a function of the number of heating–cooling cycles in dry (3 cycles) and wet (5 cycles) conditions

heating–cooling cycles all the DAP-treated samples showed lower residual strain than the untreated reference, both in dry and wet conditions, as illustrated in Fig. 11 for all the marble

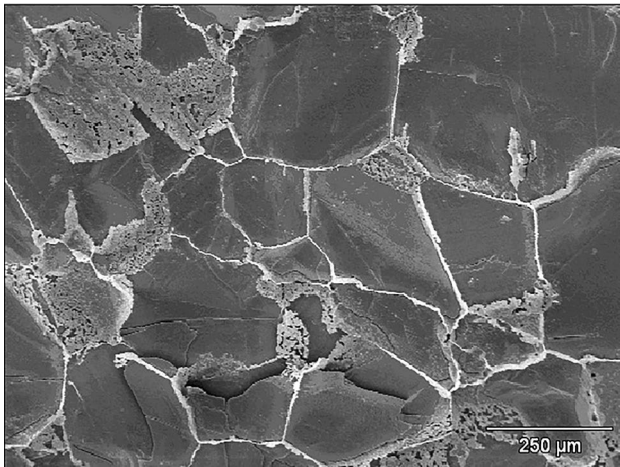
Fig. 13 PMMA filling in the pores of marble. SEM photo shows very clearly that the accessible pore space and grain boundaries are decorated with the resin

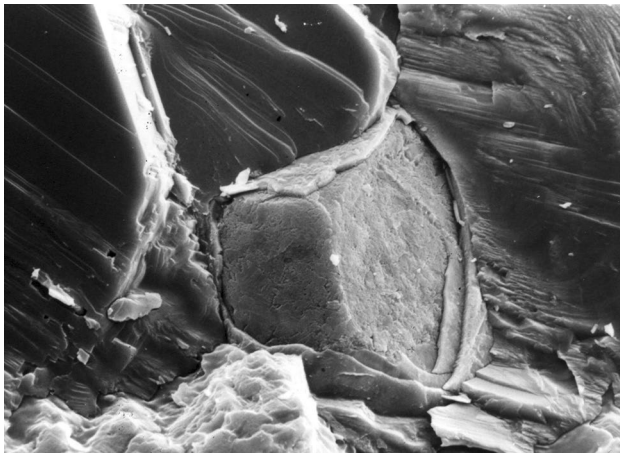
Fig. 14 Close-up of a calcite grain, which is very well coated by the impregnating agent, indicating good adherence

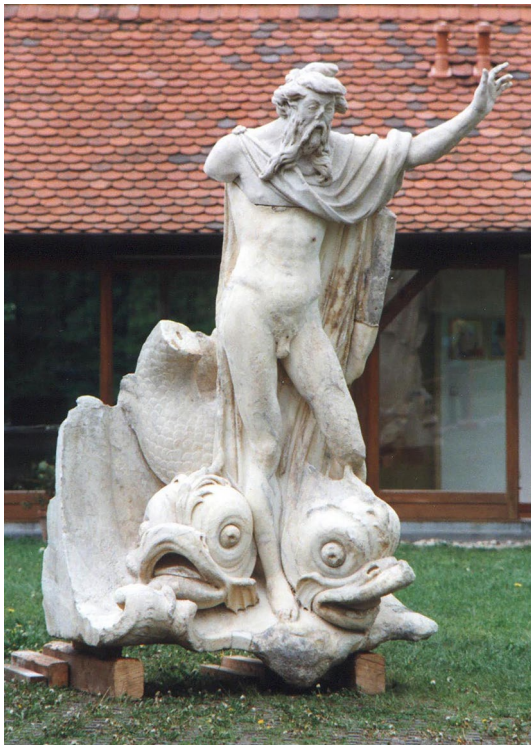
Fig. 16 The sculpture of Neptune after conservation by ATI on the premises of IbachGmbH. The ATI conservation process allows a badly damaged sculpture to return to its original site instead of final in-door storage somewhere in the cellar

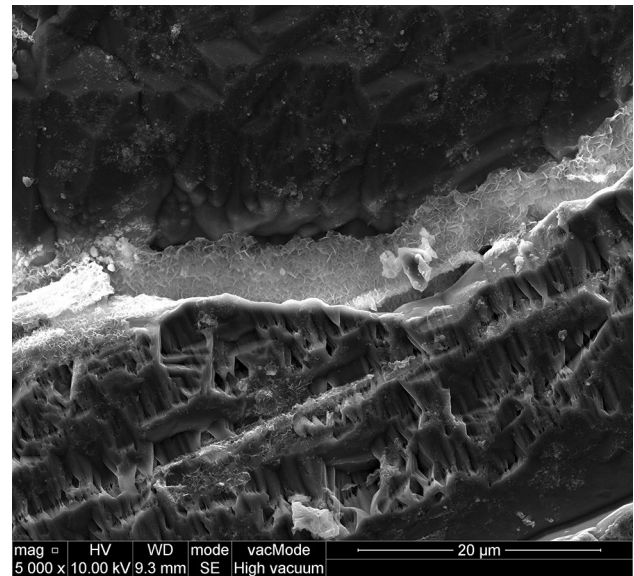
Fig. 17 SEM image clearly shows new calcium phosphates filling a microcrack among the calcite grains as a result of the DAP treatment
