The marble sculptures of General Bülow and Scharnhorst in Berlin: comparative, non-destructive analysis of the weathering state after 12 years of exposure

Abstract

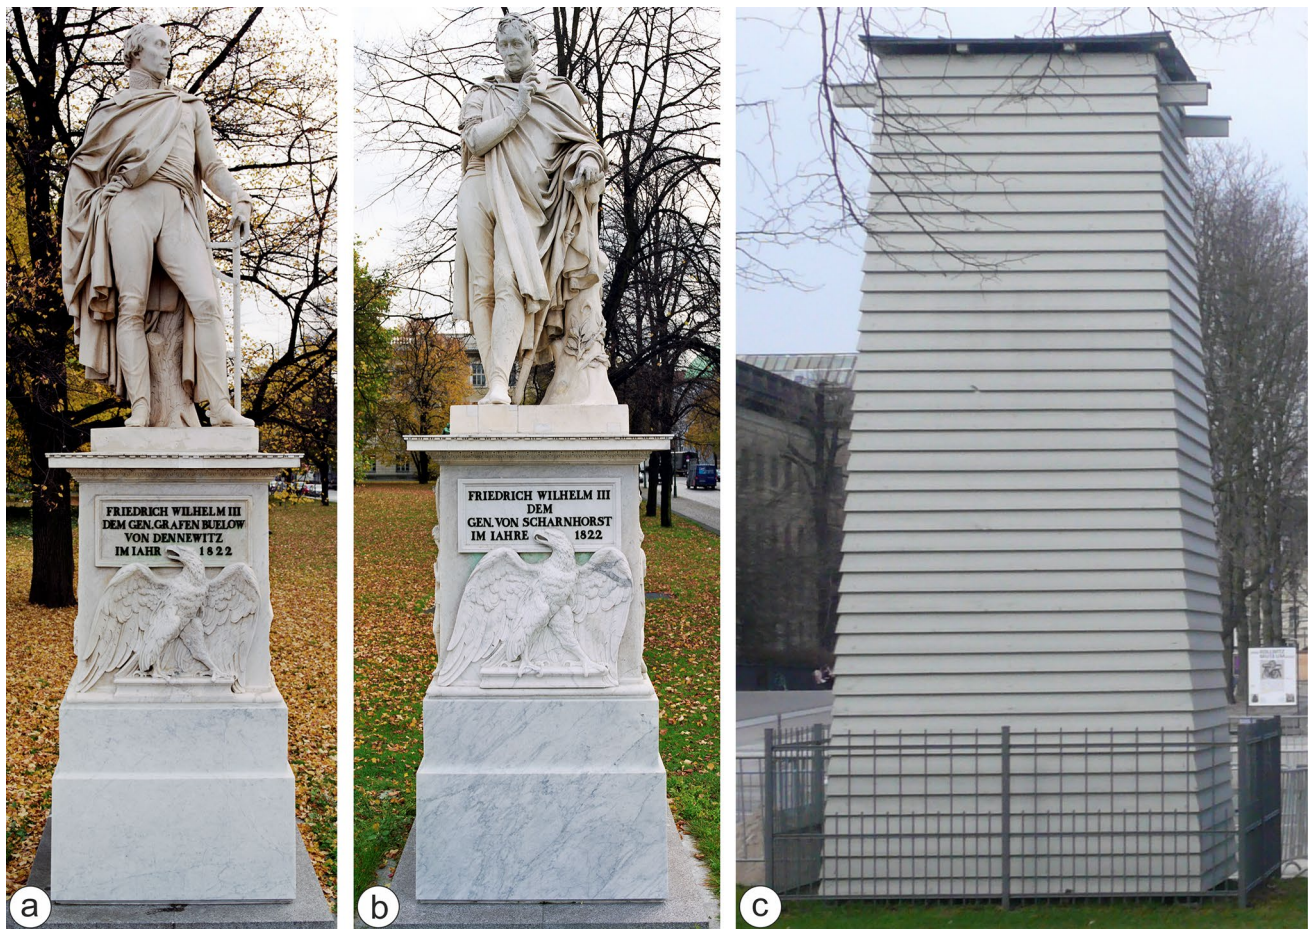
Fig. 2 Monuments of General von Bülow (a) and General von Scharnhorst (b) in their current appearance and c Sheltering of both monuments at their current location (Kai Zimmermann 2008)

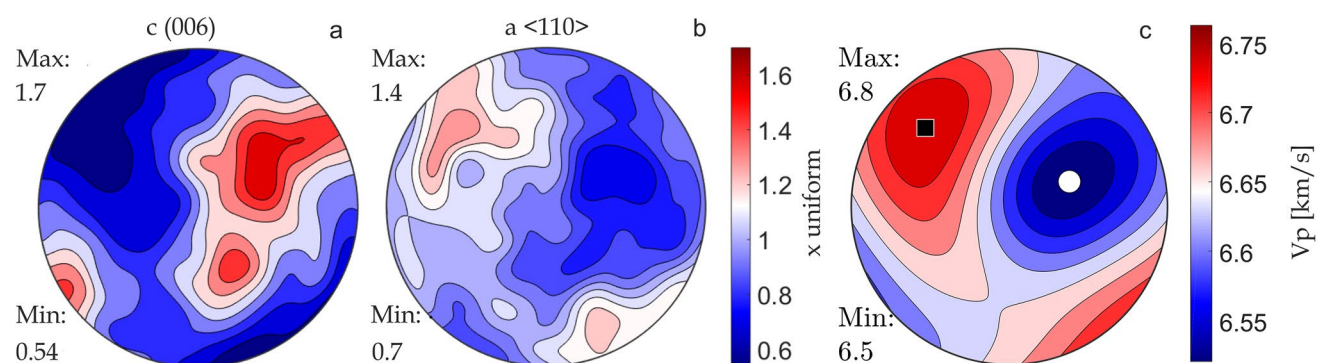
an almost girdle like *c*-axis distribution with a low, elongated *c*-axes maximum intensity of 1.7 mrd (multiple random distribution) with an oblique orientation (Fig. 5a). The *a*-axes (Fig. 5b) show a great circle distribution surrounding the *c*-axis distribution with a maximum intensity of 1.4 mrd. The weak texture is typical for Carrara marble and has been analysed by different authors (e.g. Leiss and Ullemeyer 1999; Weiss et al. 1999; Rüdrieh 2003; Rüdrieh et al. 2013).

Fig. 5 Texture (LPO) given for **a** the *c*-(006) and **b** *a*-axes $\langle 110 \rangle$. Intensities are given in mrd (multiple of random distribution), **c** 3D velocity distribution (km/s) modelled from the EBSD data of the sculpture von Bülow (lower hemisphere, stereographic projection)

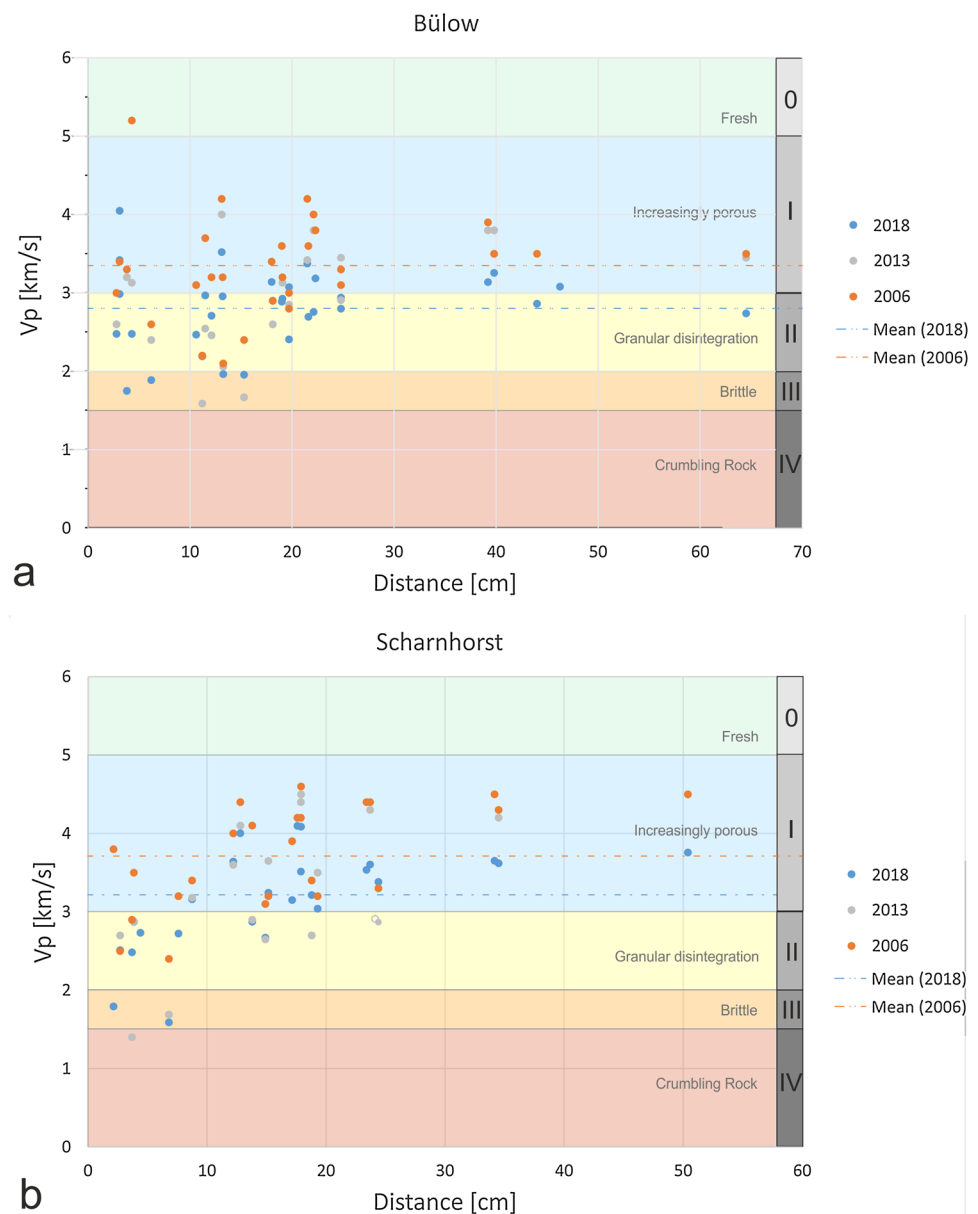
The velocities variate according to the length of the ray path. This path length varies between 3 and 64 cm for General v. Bülow, and 2 and 50 cm for General von Scharnhorst. To analyse what impact these lengths have on the velocities of the rays, they are plotted against each other in Fig. 7 (blue dots). Most velocities are analysed for ray paths between 2 and 20 cm, which range between 1.8 and 4.0 km/s for the first 10 cm, and 2.0 and 3.5 km/s for the distances between 10 and 20 cm for Bülow (blue dots in Fig. 7a). The velocities determined for the distances above 20 cm show a less strong variation of the values with velocities between 2.7 and 3.4 km/s. The velocities at short travel paths vary more strongly, while velocities at longer ray paths vary less.

However, the number of longer travel paths is relatively low. Nevertheless, this velocity variation is not uncommon for weathered marbles and is a logical consequence of deterioration and the low probability that a short ray path will cross unweathered material; whereas, long travel paths almost always pass weathered and unweathered, or low weathered, areas of the stone (Blum and Rahm 1998, Siegesmund et al. 2004). In comparison, for the General Scharnhorst sculpture (blue dots in Fig. 7b), fewer determined velocities are in the class granular disintegration. The weathering state is better than the sculpture of Bülow, but the velocities are low as well. The variation of velocities with a short ray path, smaller than 10 cm, is with 1.7–3.2 km/s lower than for the Bülow sculpture; while, they vary between 2.7 and 4.1 km/s for distances between 10 and 20 cm, which is higher than the values measured for Gen. Bülow. The longer ray paths also show a smaller range for this sculpture, while the variation within these distances is between 3.4 and 3.8 km/s. Therefore, both sculptures have a comparable weathering state, while the sculpture von Scharnhorst shows higher velocities considering the long travel paths, which is reflected in the slightly higher mean velocity of 3.2 (±0.62) km/s compared to the 2.8 km/s (±0.45) for Gen. v. Bülow. Both sculptures have suffered during the last decades; while General v.

Fig. 7 The measured transmission velocities (km/s) of von Bülow (a) and von Scharnhorst (b) plotted according to the distance (cm) the ray needed to travel. The dashed line represents the average velocity

Scharnhorst shows a lower state of deterioration, even if the Bülow sculpture was less exposed to the environment.

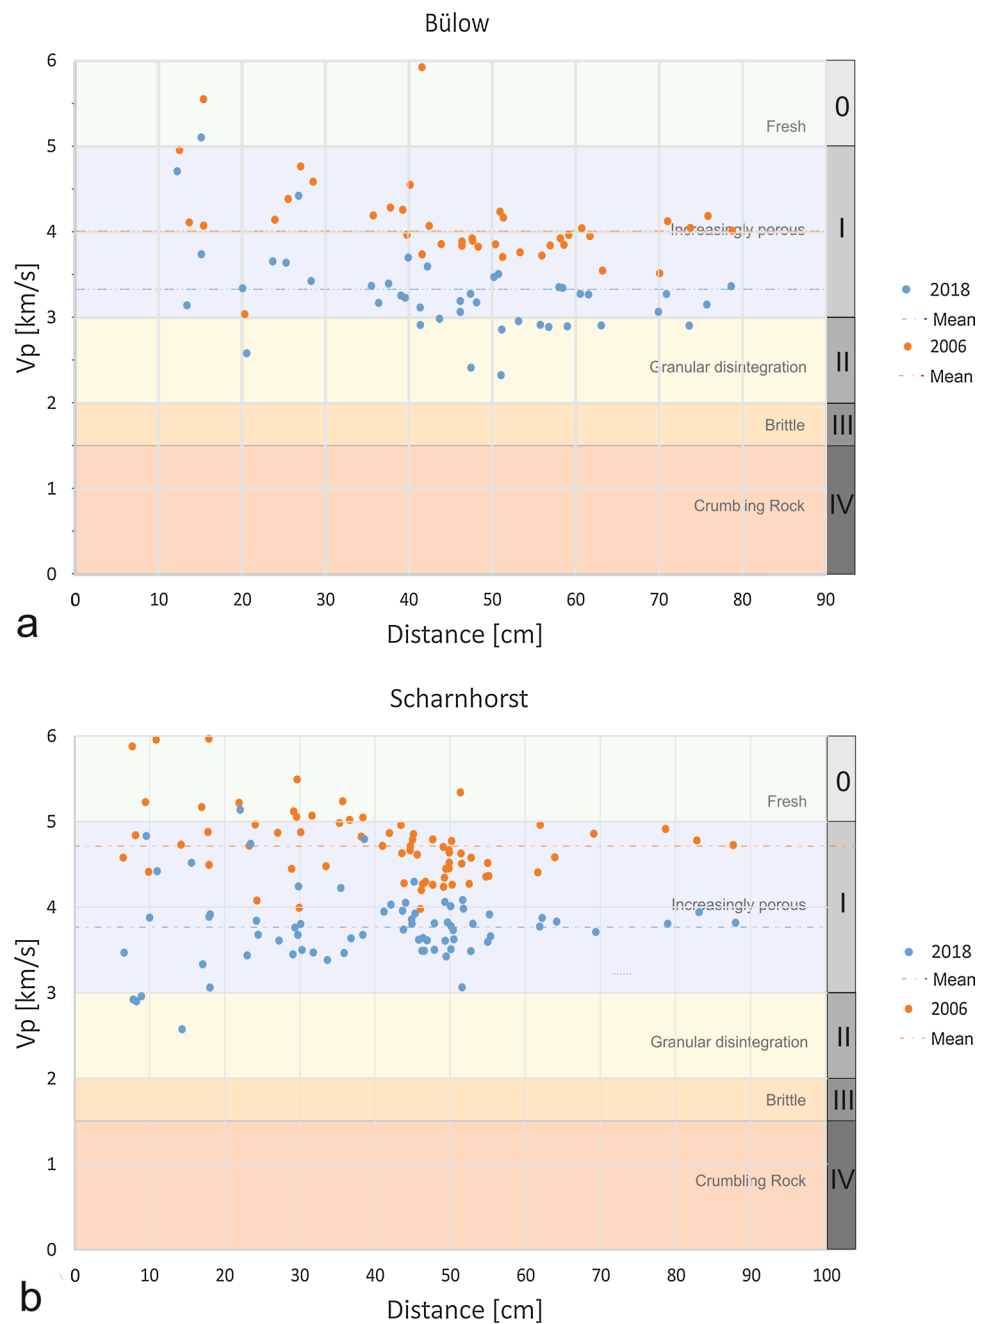
Independent of the length of the travel path, all measured the velocities continued to decline since 2006. The mean velocity of $4.0 (\pm 0.5)$ km/s declined around 0.7 km/s down to $3.3 (\pm 0.44)$ km/s in the last 12 years for General v. Bülow and around 1.0 km/s from $4.8 (\pm 0.5)$ km/s down to $3.8 (\pm 0.43)$ km/s for General v. Scharnhorst. The most astonishing result is that even the velocities for long distances of more than 40 cm show a significant reduction of about 1 km/s, indicating a strong deterioration. Another

Fig. 12 Measured ray velocities (km/s) of the tomogram for von Bülow (a) and von Scharnhorst (b) in 2018 (blue dots) and 2006 (red dots) plotted according to the distance (cm) the ray needed to travel. The dashed line represents the average velocity

interesting aspect is that all velocities for the shorter distances of General v. Bülow are the same or higher than the values for longer distances. Higher velocities are not uncommon for shorter distances and can be caused by different reasons (e.g. Lindner et al. 1999), but that more or less all measured velocities for short distances of a weathered marble are higher than those for longer distances is quite unusual (e.g. Fleischer 2002; Rüdrieh et al. 2013).

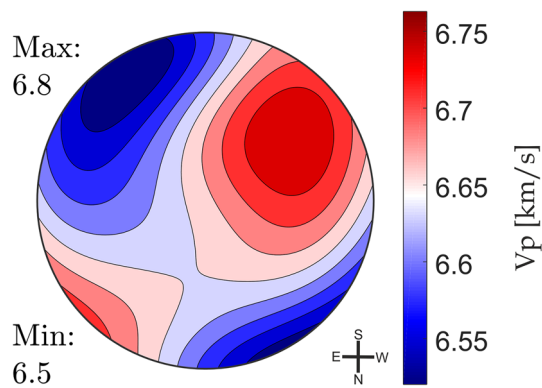
The distribution of the ultrasonic velocity depends on the lattice preferred orientation. Therefore, the modelled three-dimensional ultrasonic velocity for the sculpture of General von Bülow (see Fig. 5c) was rotated about 90° (Fig. 15) to have the same orientation as the two-dimensional tomograms (Fig. 13). The displayed velocity is given at the lower hemisphere and cannot be directly transferred to the measured layer in Fig. 13, as they show different dimensions. Nevertheless, the area of low velocities in Fig. 13 could be influenced by the texture, while an isotropic velocity distribution could also be possible. Since the two-dimensional velocity distribution for the specific section could not be determined, no clear determination of the intrinsic velocity distribution can be given for the specific tomographic section. The amount of decay phenomena and heterogeneities can only be quantified if the anisotropic velocity variation is considered. But as the texture is only weakly pronounced and even the measurements at the drill core showed no clear directional dependence, the influence based on anisotropy seems to be negligible.

Fig. 15 Reoriented, modelled 3D velocity distribution adjusted to the 2D tomogram of the sculpture von Bülow. The orientation is the same as for the sculpture, see compass direction
